# Shelling of the eastern residential Quarters of Luhansk with the use of Grad MLRS

## February 12, 2015.

*PUBLIC INVESTIGATION*

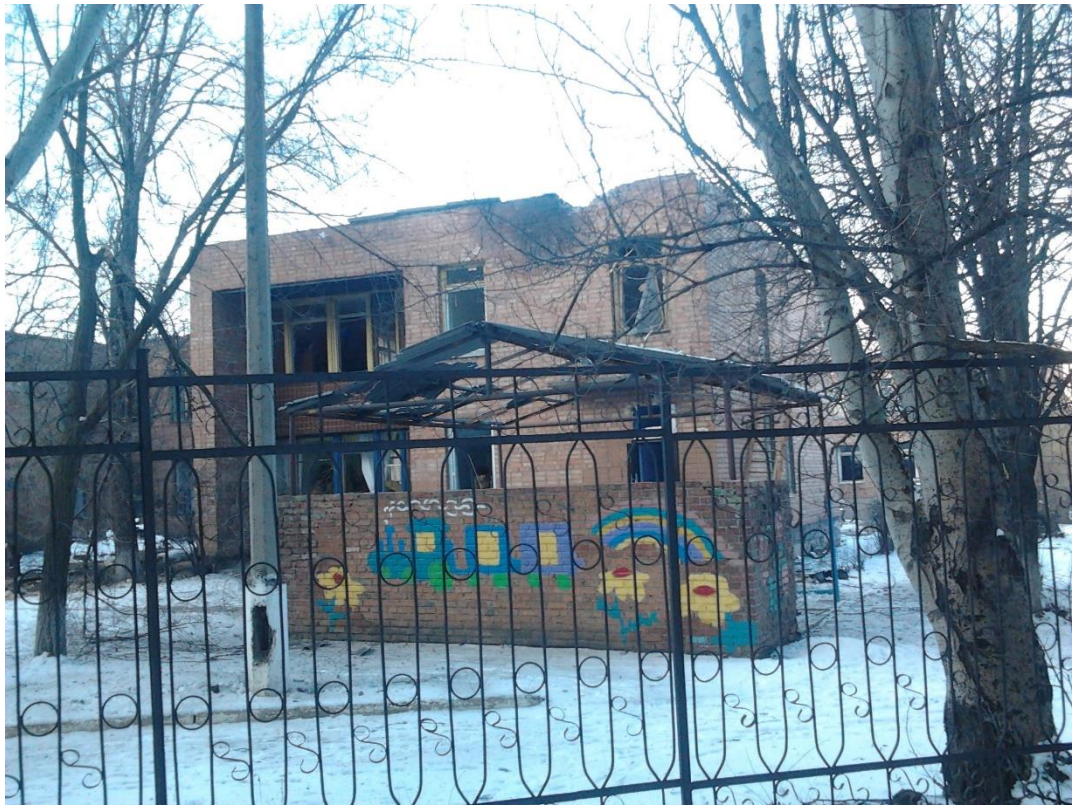
**Shell hit 1** (see Fig. 2, Fig. 3). The shell hit the southern corner of the roof of the kindergarten No. 129 (at 9A, Dzerzhinsky Quarter). As a result of the projectile detonation, part of the roof near the southern corner of the building was destroyed.

*Fig. 2 - The roof of the kindergarten No. 129, destroyed by shell hit 1<sup>32</sup>.*

had suffered a direct hit to the roof by what the SMM estimated to have been a Grad rocket. The SMM observed that the impact had destroyed part of the roof, at least one room of the facility and shattered windows. In Klubnaya Street, the SMM observed remnants of a Grad rocket on the tarmac, which the SMM assessed had caused damages to the walls and roofs of nearby houses and shattered windows.<sup>11</sup>

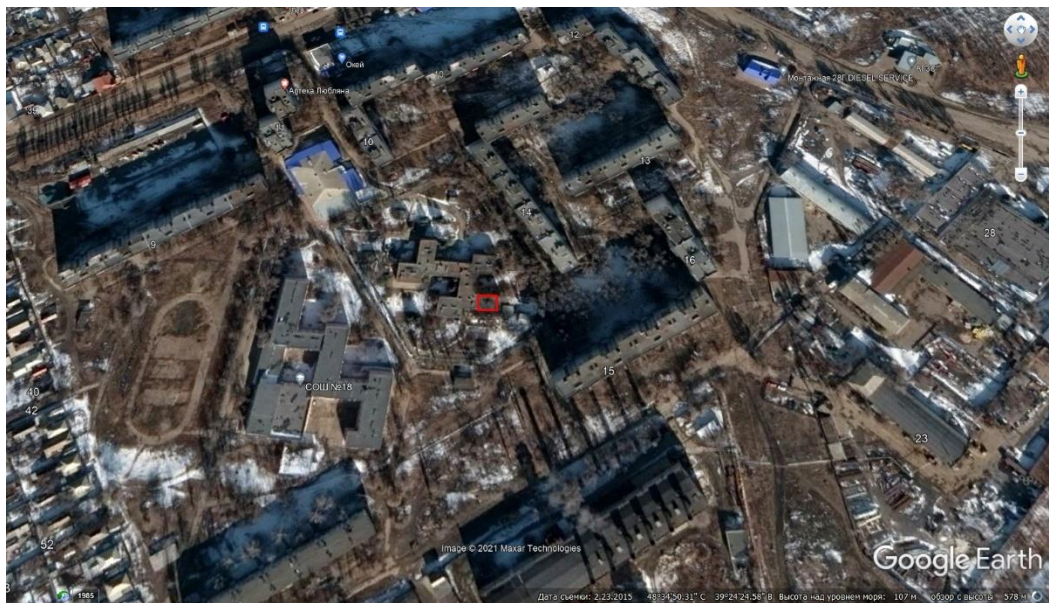
*Fig. 3 – The trail of a shell hit 1 on the roof of Nursery School No. 129 on the satellite image dated 23.02.2015*

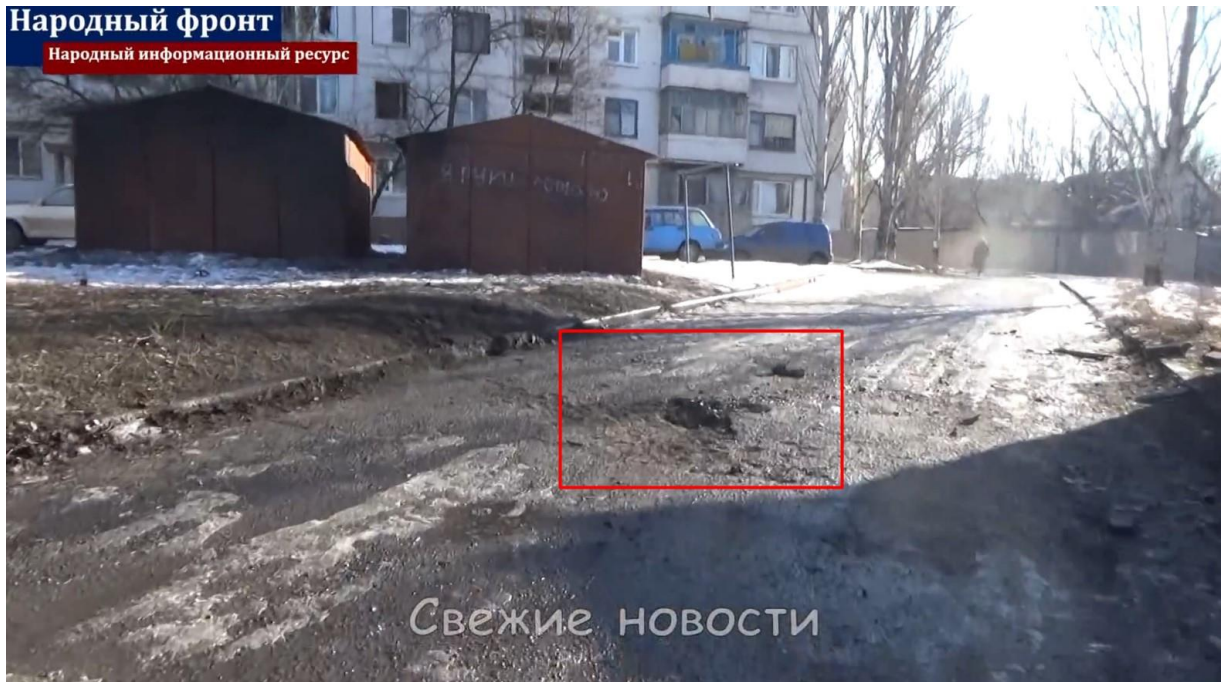
**Shell hit 2** (see Fig. 4, Fig. 5). The shell hit the asphalt surface about 30 meters to the north of the western corner of residential building No. 81 in Klubnaya Str. The projectile detonation resulted in a shell crater with metal fragments in the crater center, identified as the remains of the MLRS projectile missile part (hereinafter referred to as MP).

*Fig. 4 – A crater from shell hit 2 on an asphalt surface 30 meters north of the western corner of the residential building at 81, Klubnaya street, Lugansk<sup>33</sup>.*

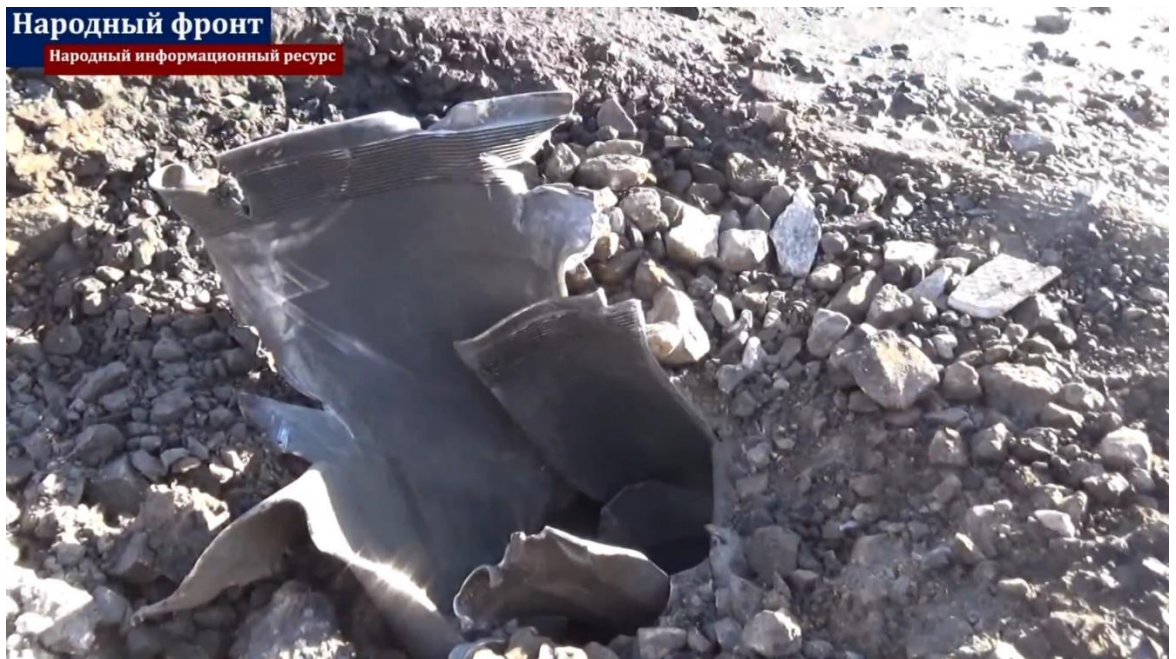
*Fig. 5 - Metal fragments, identified as the remains of a MLRS projectile MP, in the crater from shell hit 2<sup>34</sup>.*

Remains of rocket MP were found at shell hits 2, 6, 10, and 12 (see Fig. 5, Fig. 9, Fig. 14, Fig. 17).

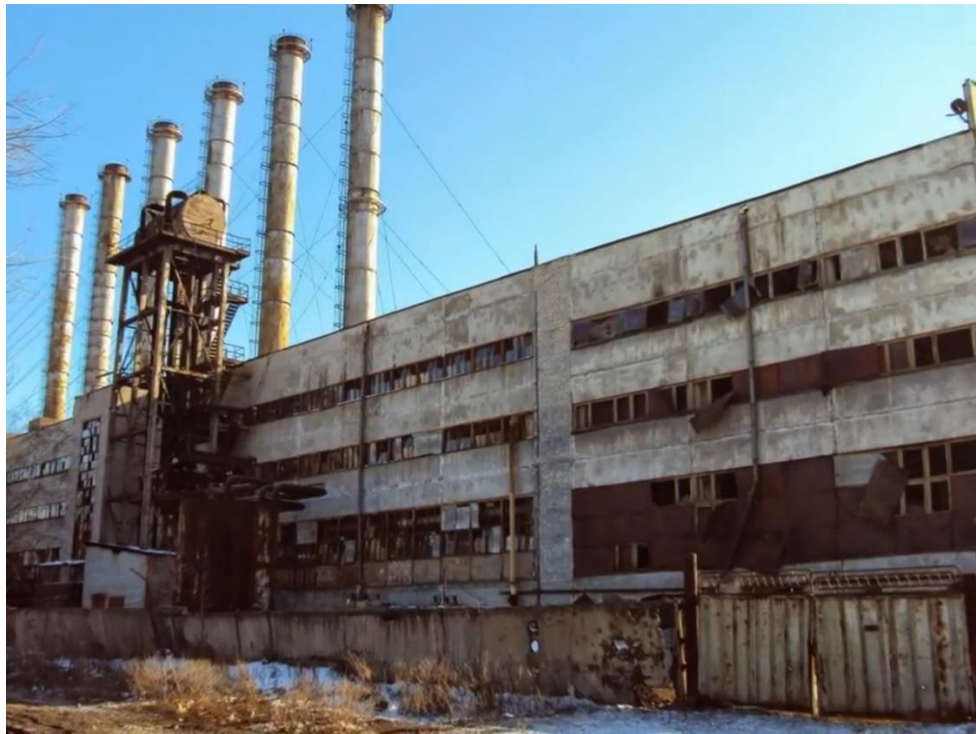
**Shell hit 3** (see Fig. 6). The shell hit occurred in the territory of the municipal boiler house (building No. 23A in Klubnaya Str). The projectile detonation resulted in the damage of the reinforced concrete fence.

*Fig. 6 – The building of the municipal boiler station damaged by shell hit 3<sup>35</sup>.*

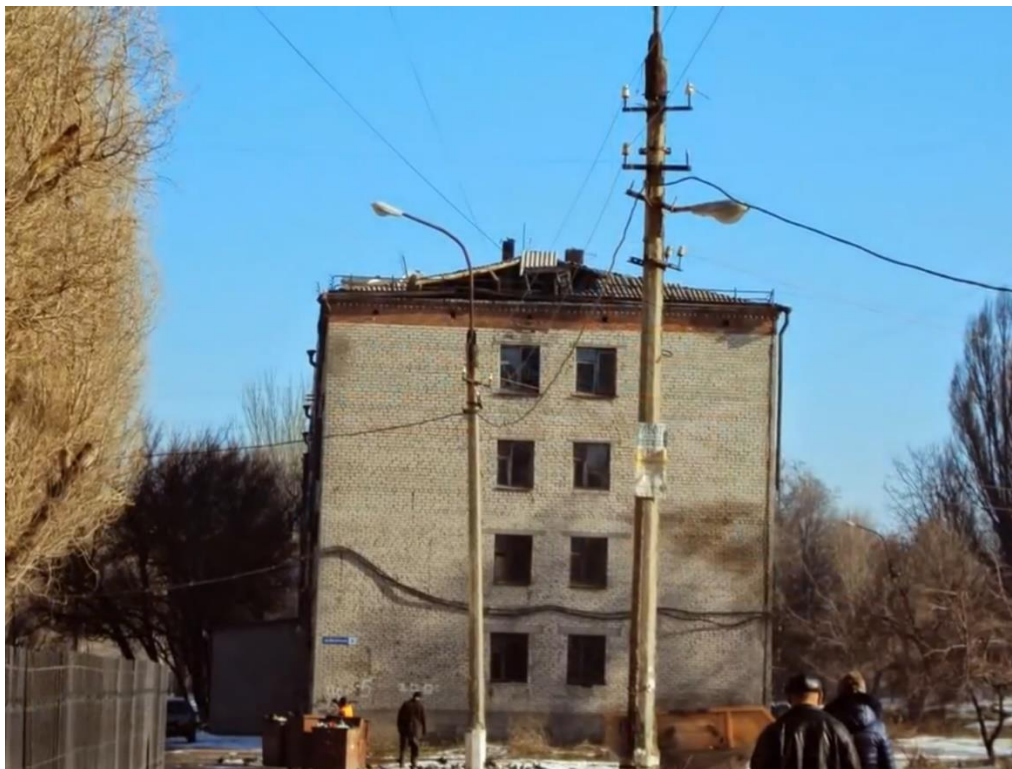
**Shell hit 4** (see Fig. 7). The shell hit the roof in the western side of the residential building at 5, Dzerzhinsky Quarter. As a result of the projectile detonation, part of the roof near the western side of the building was destroyed.

*Fig. 7 – The roof of the building damaged by shell hit 5<sup>36</sup>.*

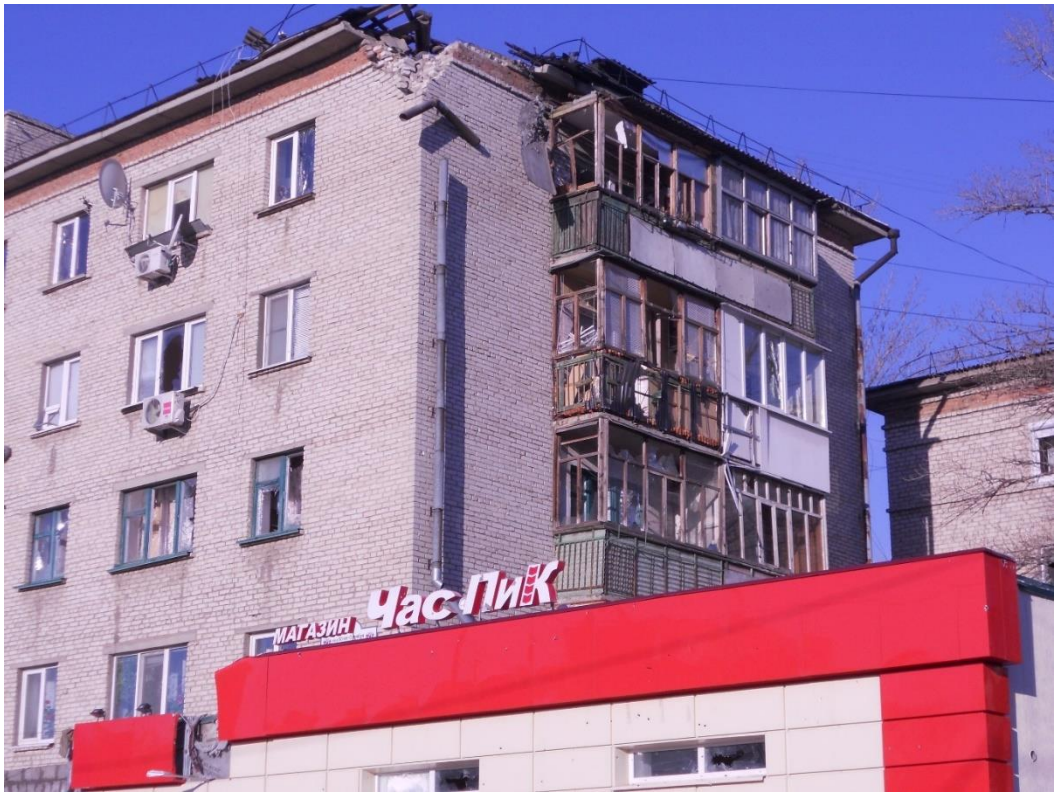
**Shell hit 5** (see Fig. 8). The shell hit the eastern corner of residential building at 29, The 50th Anniversary of October Quarter. As a result of the projectile detonation, part of the roof was destroyed. Brickwork near the eastern corner was damaged.

*Fig. 8 –The eastern corner of the residential building destroyed as a result of shell hit 5<sup>37</sup>.*

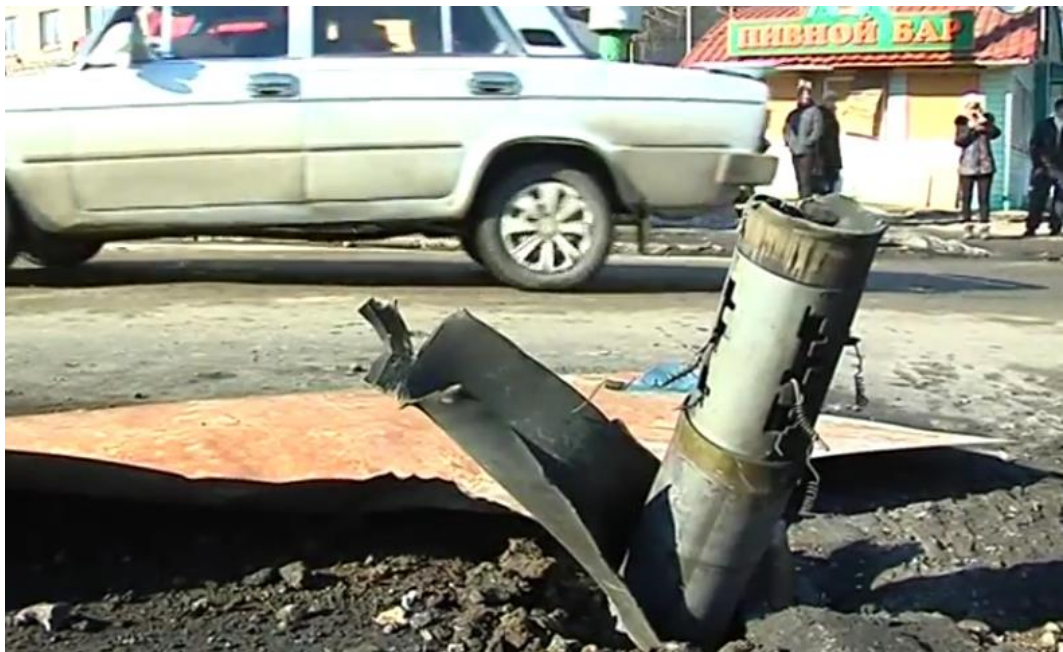
**Shell hit 6** (see Fig. 9, Fig. 10). The shell hit paved surface about 15 meters south of the rear of the Pivnoy Bar kiosk (29G, The 50th Anniversary of October Quarter.) The projectile detonation resulted in a shell crater in the traffic lane with a metal tube in the crater center, identified as the remains of the MLRS projectile MP. A man died from shrapnel wounds at the site of the projectile detonation<sup>7</sup>.

*Fig. 9 - Metal tube, identified as the remains of a MLRS projectile MP, in the asphalt pavement at the site of shell hit 6<sup>38</sup>.*

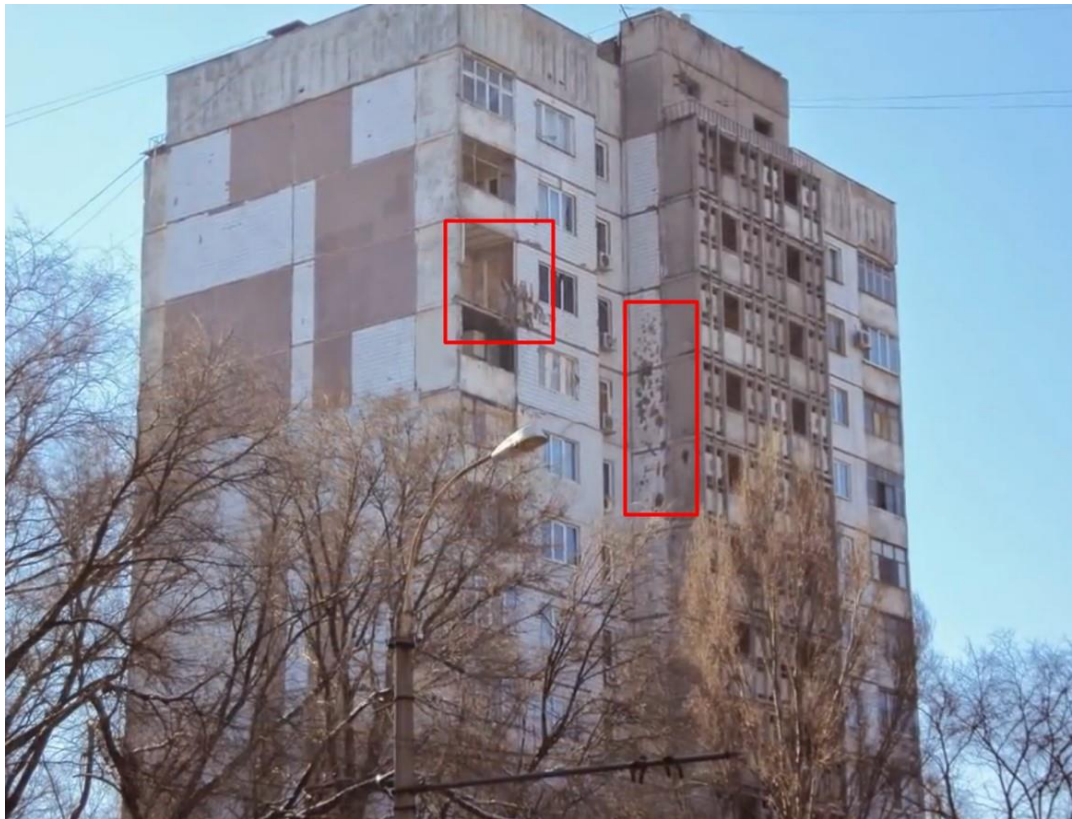
**Shell hit 7** (see Fig. 11). The shell hit the north-western wall of the residential building at 7, Gagarin Quarter. As a result of the projectile detonation, the balcony near

the northern corner of the building was destroyed at the level of the 10th floor. There were multiple damages from shell fragments on the wall of the entrance ledge at the level of 8 to 10 floors.

*Fig. 11 – Destroyed balcony and traces from the main scatter of fragments at the impact site of shell hit 7<sup>40</sup>.*

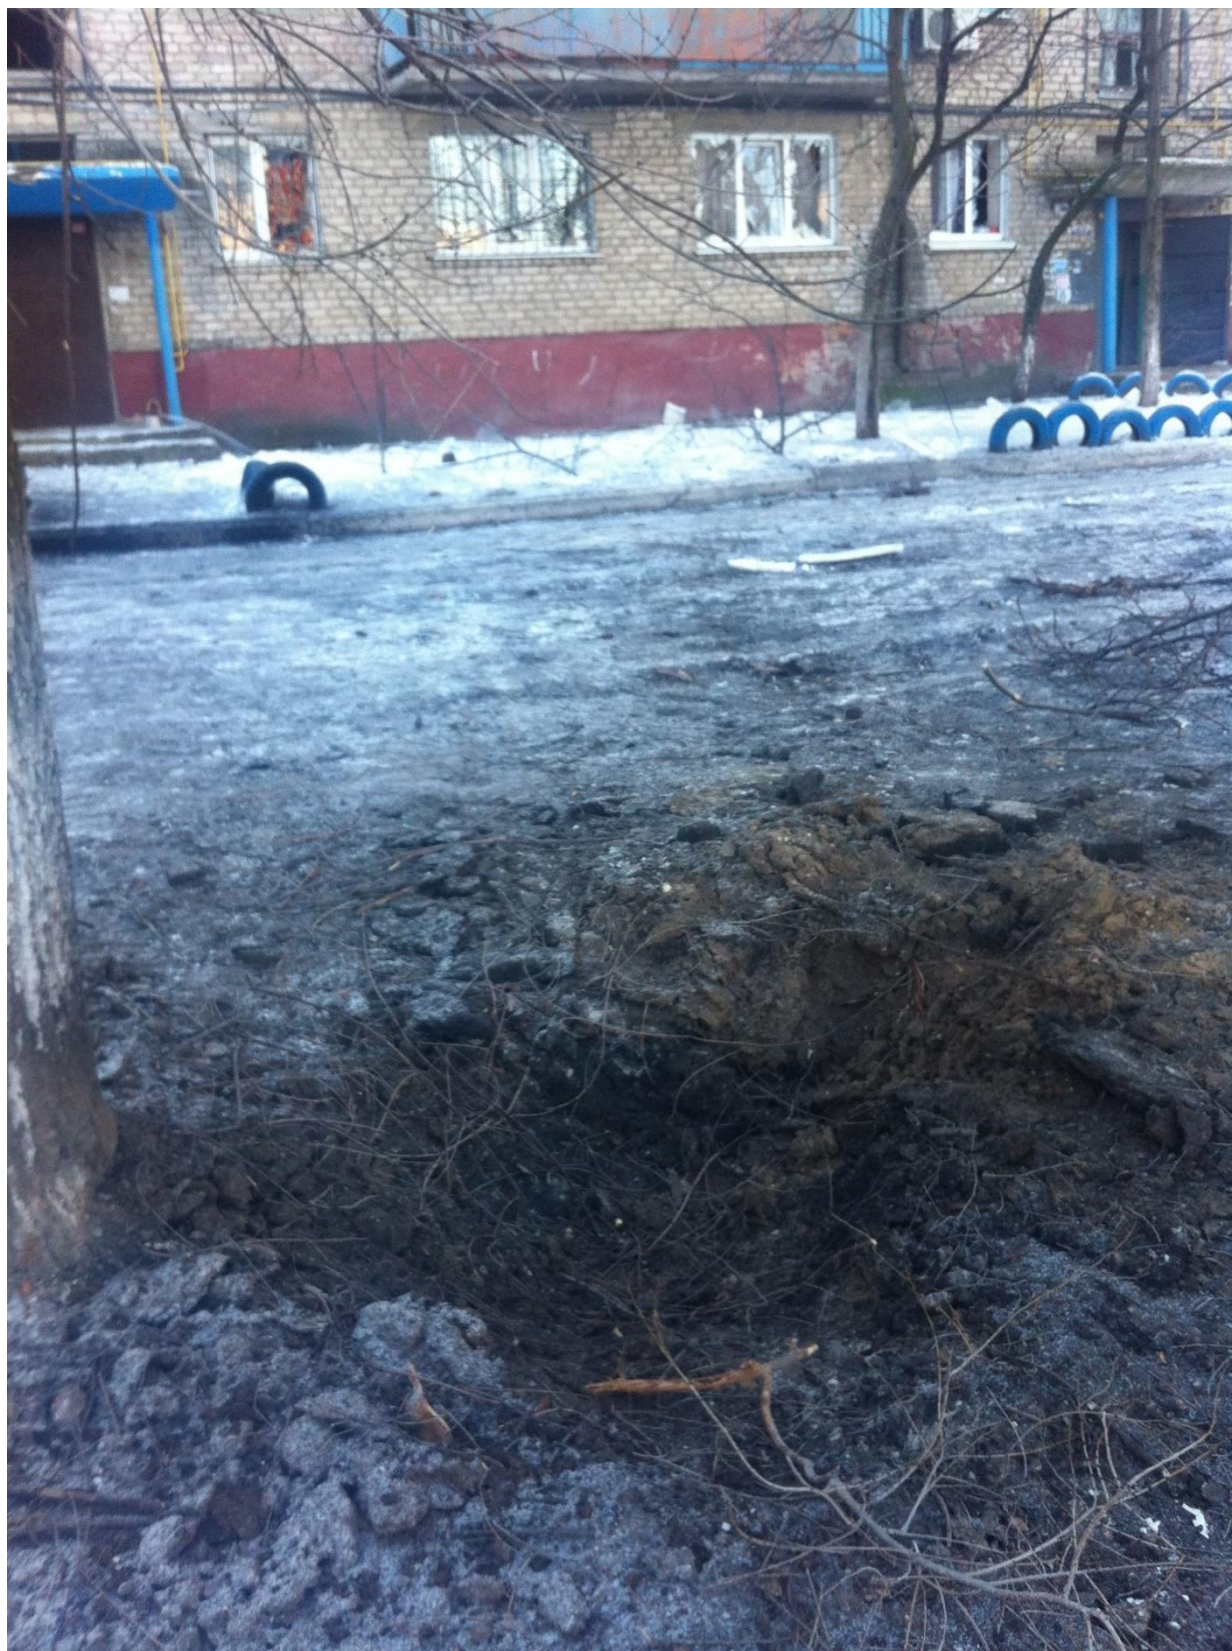
**Shell hit 8** (see Fig. 12). The shell hit the ground surface a few meters north-west of the fourth entrance of the multi-storey residential building 6 in Gagarin Quarter. The projectile detonation resulted in a shell crater in the ground.

*Fig. 12 – The shell crater found at the site of shell hit 8<sup>41</sup>.*

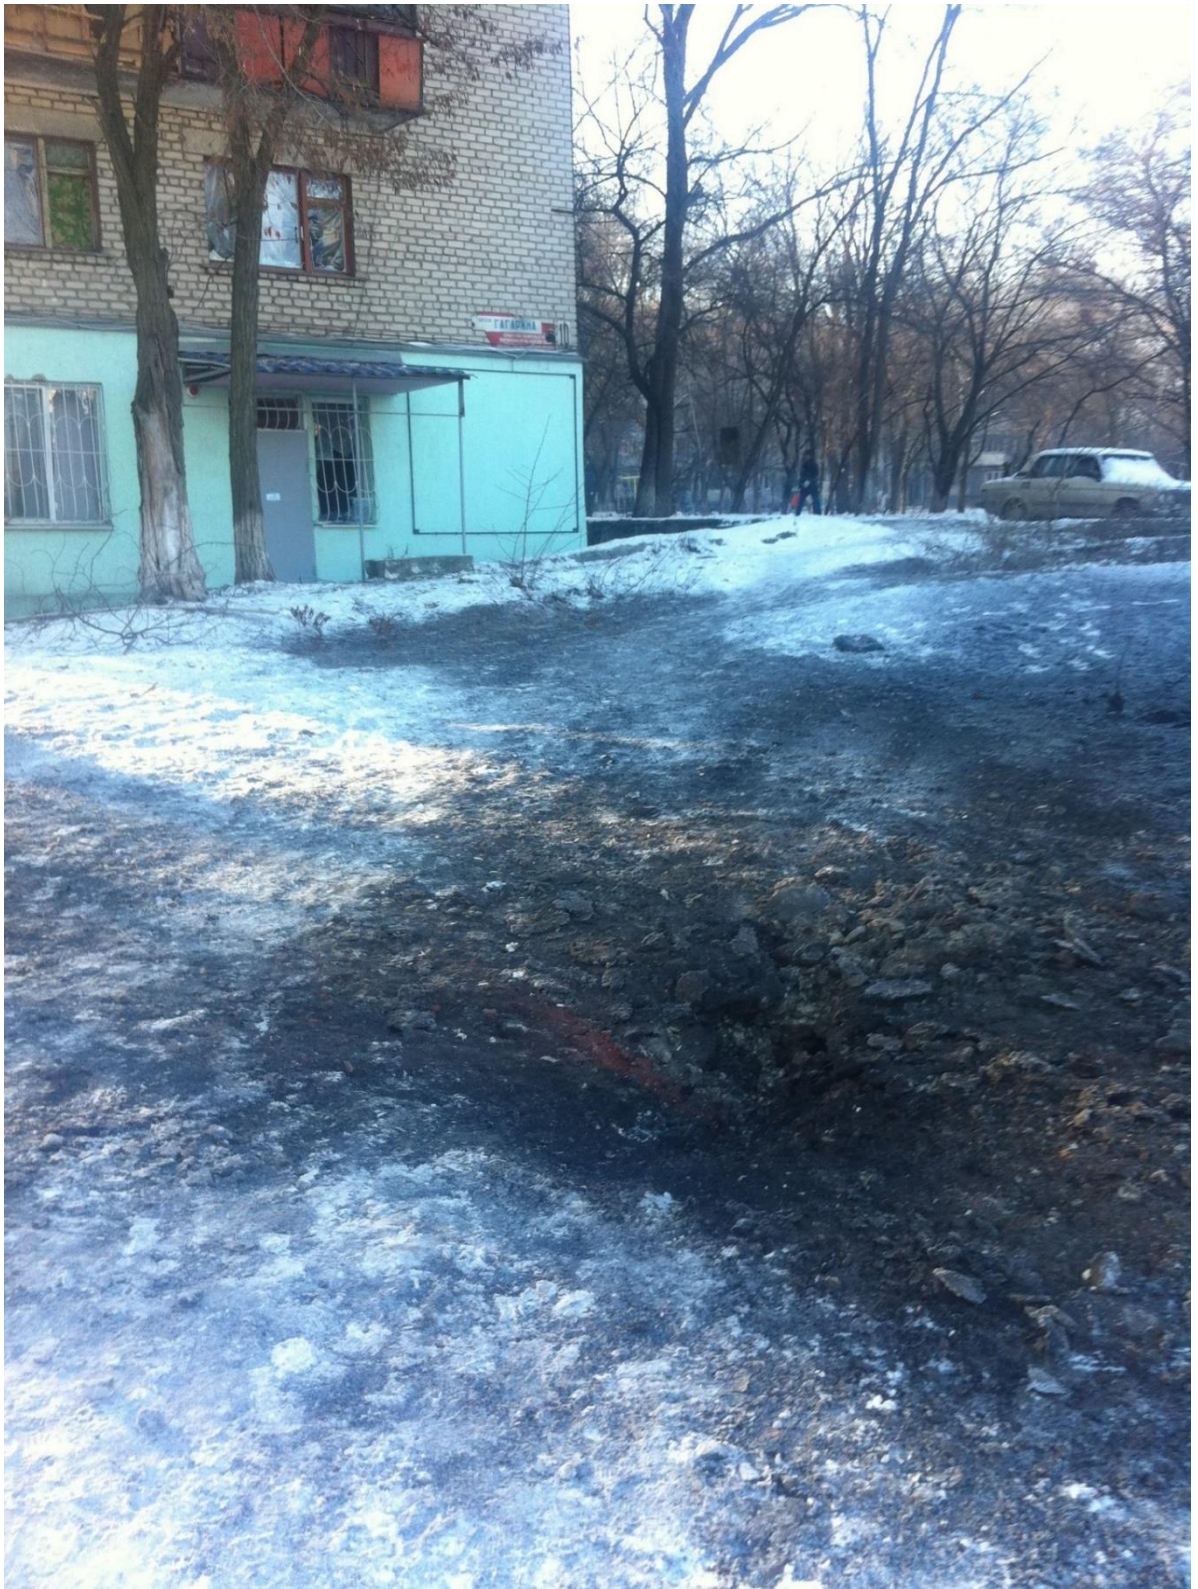
**Shell hit 9** (see Fig. 13). The shell hit the ground surface a few meters from the northern side of the residential building 10 in Gagarin Quarter. The projectile detonation resulted in a shell crater in the ground.

*Fig. 13 – The shell crater found at the site of shell hit 9<sup>42</sup>.*

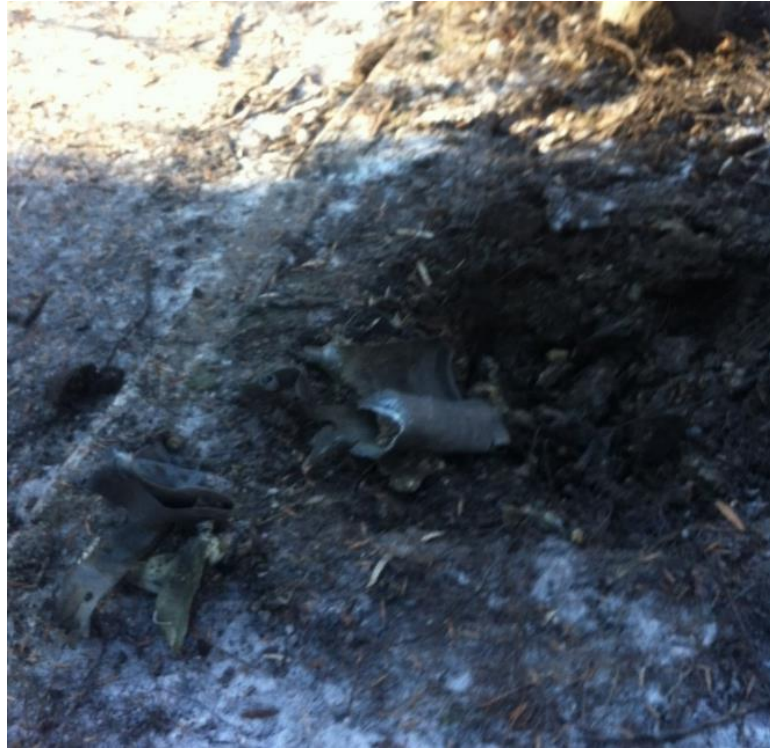
**Shell hit 10** (see Fig. 14, Fig. 15). The shell hit the ground surface a few meters north-west of the fourth entrance of the multi-storey residential building 13 in Gagarin Quarter. The projectile detonation resulted in a shell crater in the ground with metal fragments in the crater center, identified as the remains of the MLRS projectile MP. Multiple damages were formed on the wall of the building from the main scatter of fragments.

*Fig. 14 - Remains of a MLRS projectile RF in a crater at the impact site of shell hit10<sup>43</sup>.*

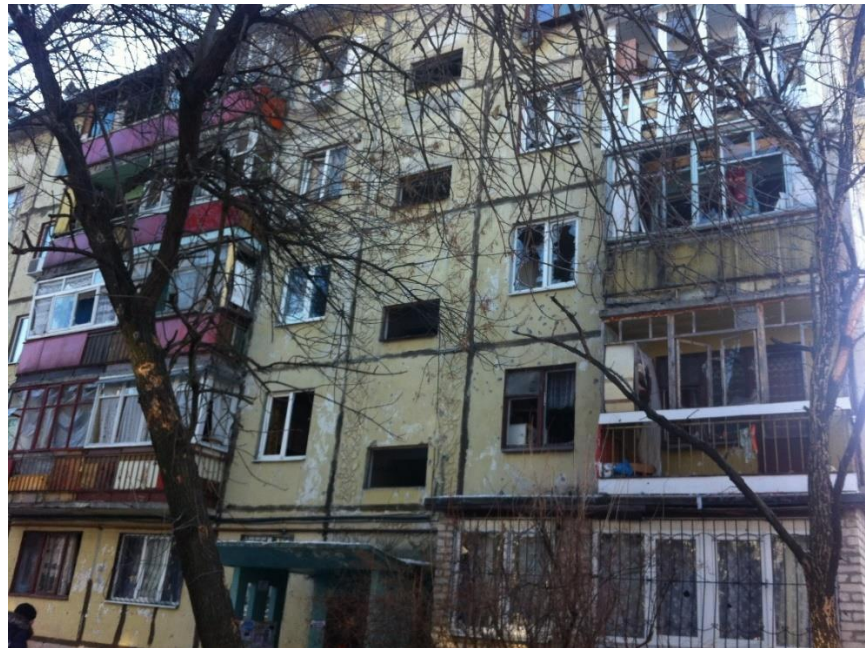
*Fig. 15 – Consequences of a projectile detonation a few meters from shell hit 10<sup>44</sup>.*

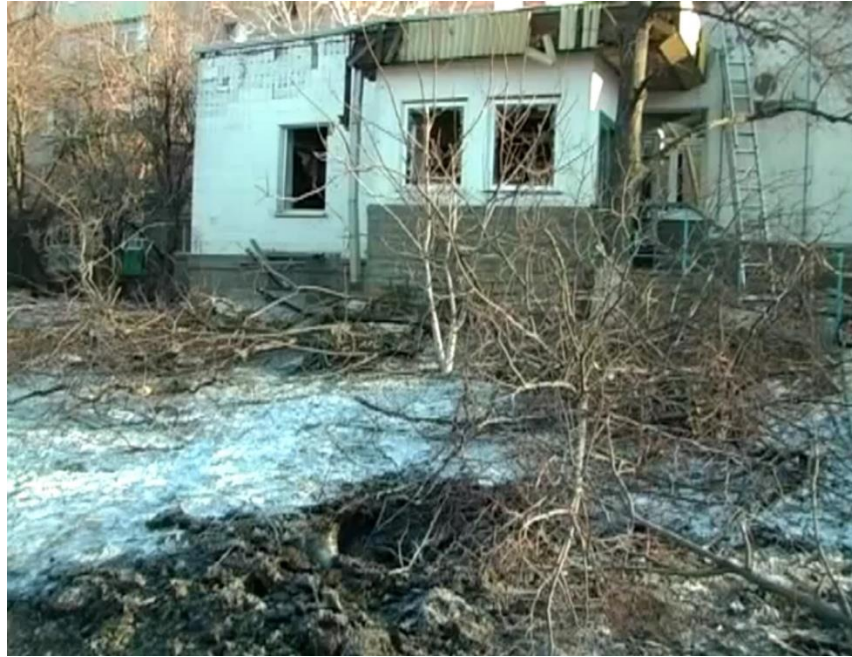
**Shell hit 11** (see Fig. 16). The shell hit the ground surface at about ten meters south-west from the western corner of the fire station (at 51, 30 years of Victory Street). The projectile detonation resulted in a shell crater in the ground. The upper part of the wall of the building was damaged by fragmentation.

*Fig. 16 – A crater from shell hit 11<sup>45</sup>.*

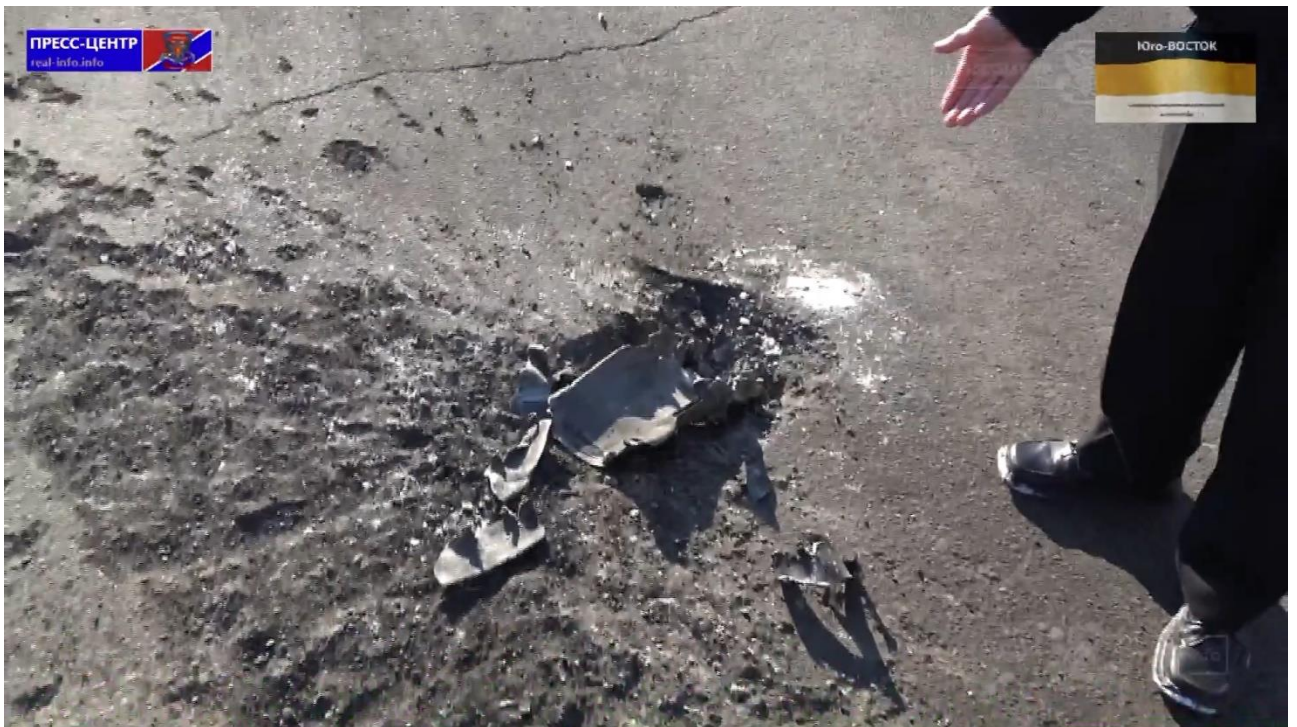
**Shell hit 12** (see Fig. 17, Fig. 18). The shell hit the asphalt pavement about 28 meters west of the main entrance to the Absolut supermarket (at 81G, Smolenskaya Street). The projectile detonation resulted in a shell crater in the asphalt pavement with a clearly defined trace from the main scatter of fragments. There were metal fragments identified as an MLRS projectile MP in the center of the crater.

*Fig. 17 - Remains of a MLRS projectile RF in a crater at the impact site of shell hit 12<sup>46</sup>.*

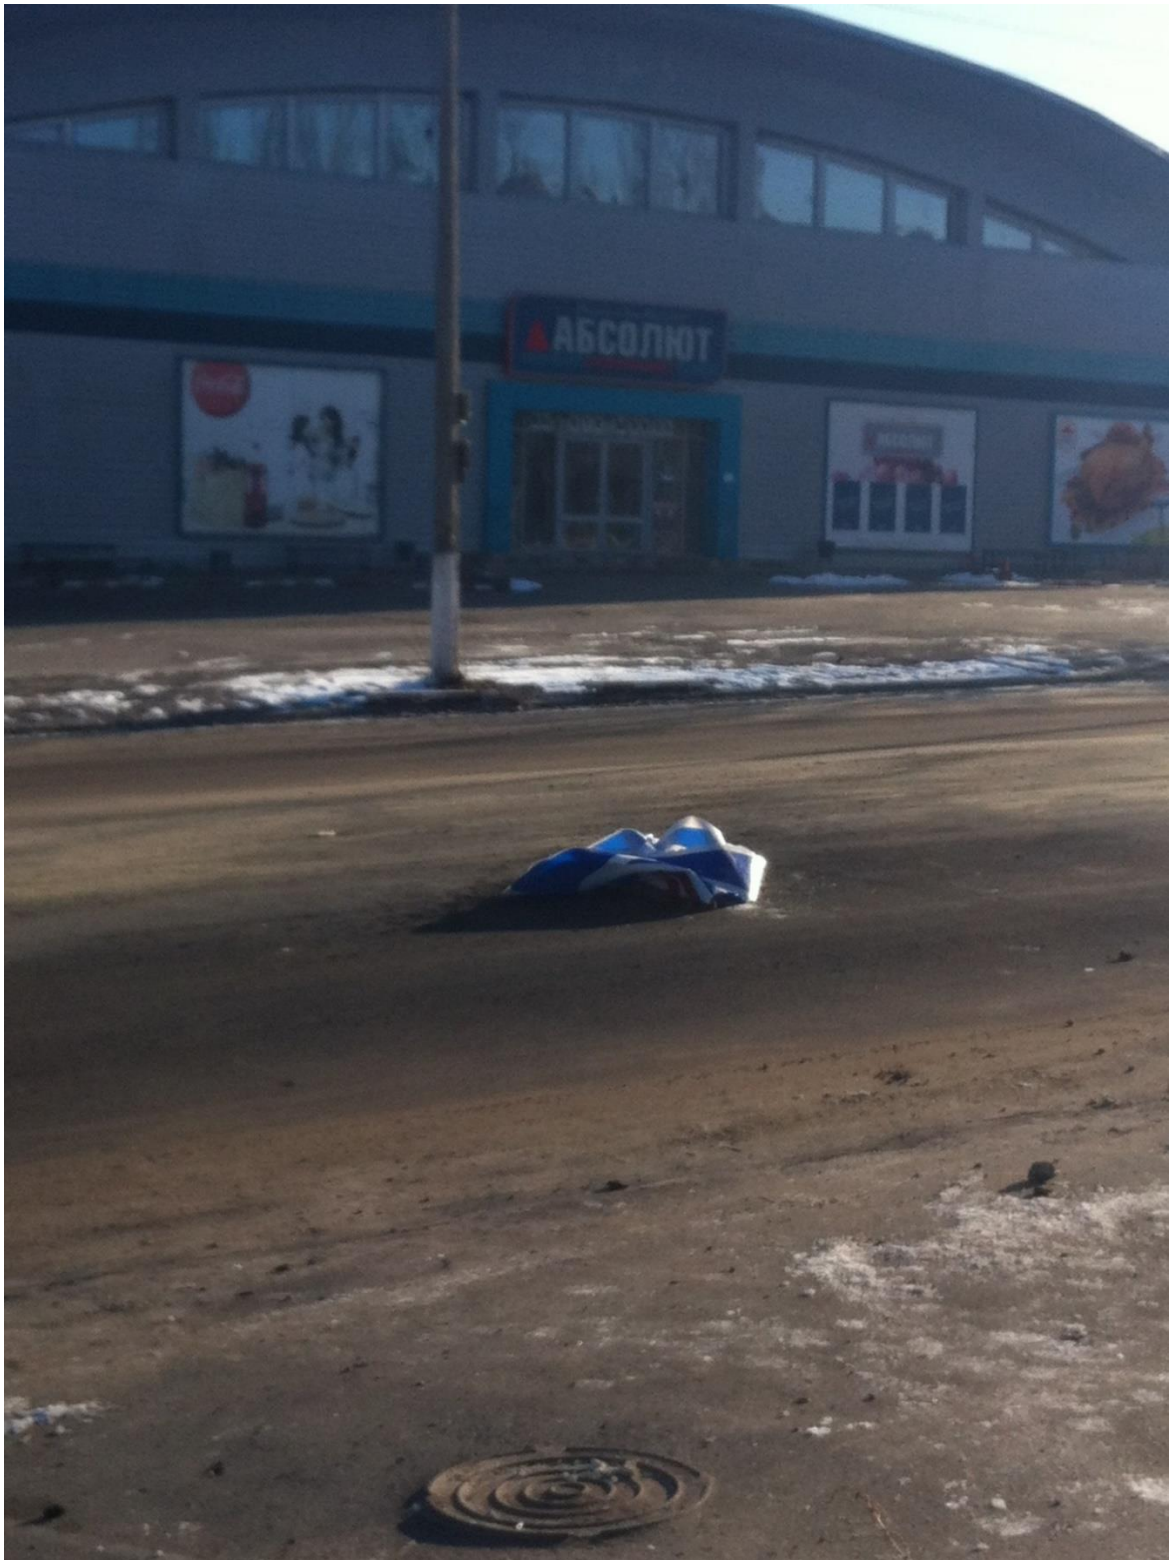
*Fig. 18 – The crater from shell hit 12, located under the torn off sign of the ATB supermarket<sup>47</sup>.*

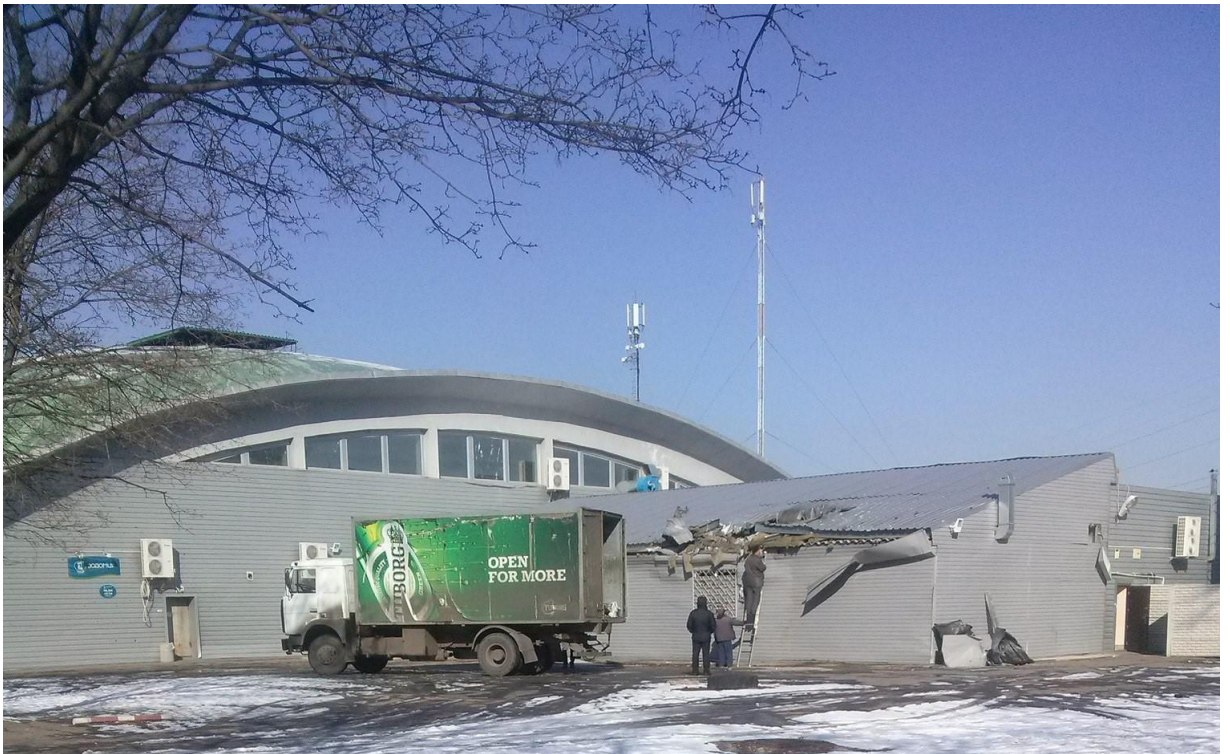
**Shell hit 13** (see Fig. 19, Fig. 20). The shell hit the roof of an extension located on the south side of the Absolut supermarket building (at 81G, Smolenskaya Street). The projectile detonation resulted in a hole in the roof of the extension, the equipment that was in the premises was damaged by fragments.

*Fig. 19 – Part of the roof damaged by shell hit 13<sup>48</sup>.*

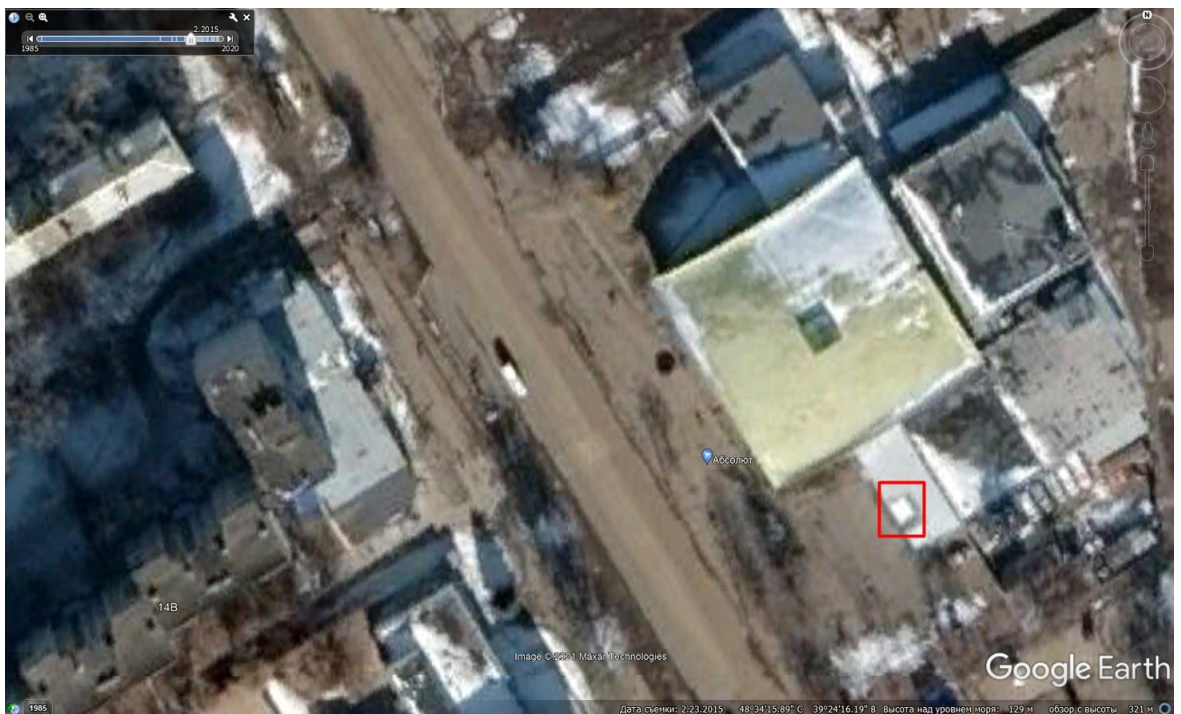
*Fig. 20 – The trail of a shell hit 13 in the roof of the Absolut supermarket on the satellite image dated 23.02.2015.*

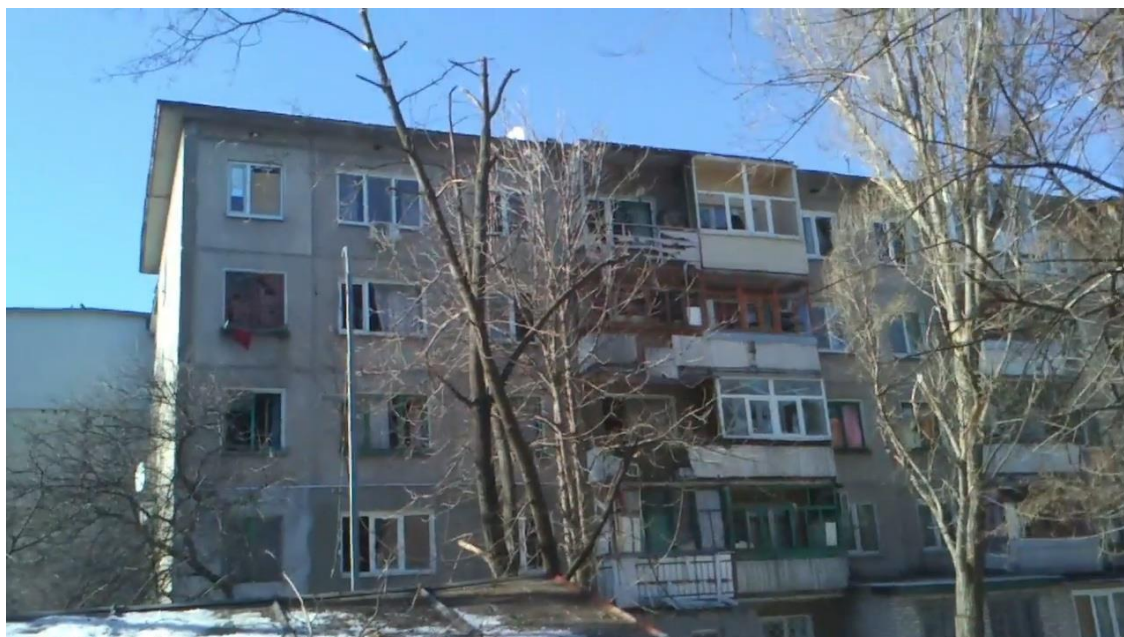
**Shell hit 14** (see Fig. 21, Fig. 22, Fig. 23, Fig. 24). The shell hit occurred in the park area between residential buildings 33 and 35 in Volkov Quarter. The exact place

of the shell hit is unknown, most likely, the detonation occurred in the treetop. The main scatter of fragments damaged glazing in three houses and a commuter bus. The body of a man who died from shrapnel wounds was found between residential buildings 33 and 35<sup>8</sup>.

*Fig. 21 – The treetop in which the projectile detonated during shell hit 14<sup>49</sup>.*

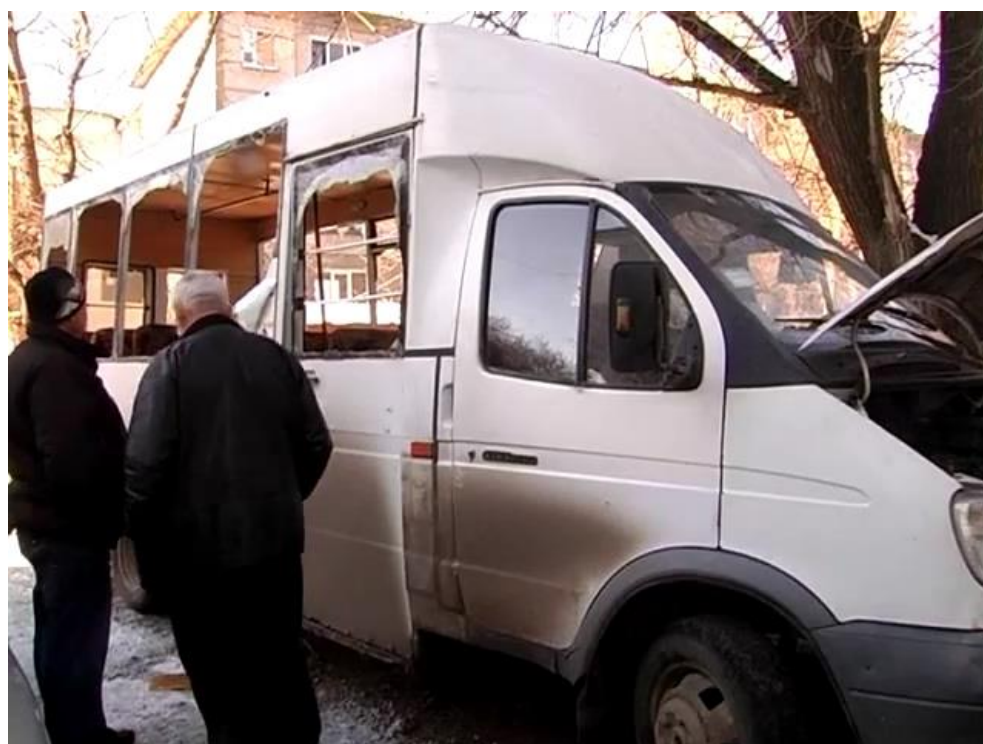
*Fig. 22 – The commuter bus damaged by the main scatter of fragments a few meters from shell hit 14<sup>50</sup>*

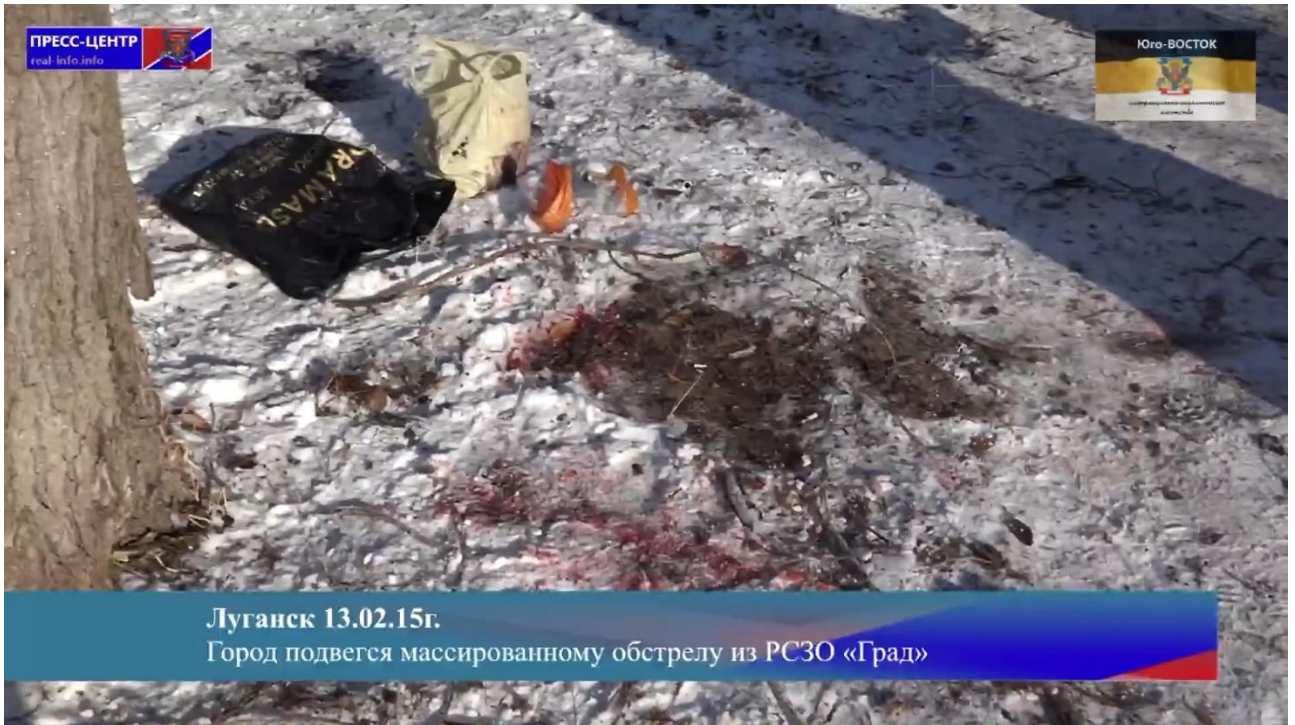
*Fig. 23 – The blood traces and personal belongings of a man who died of shrapnel wounds a few meters from shell hit 14<sup>51</sup>.*

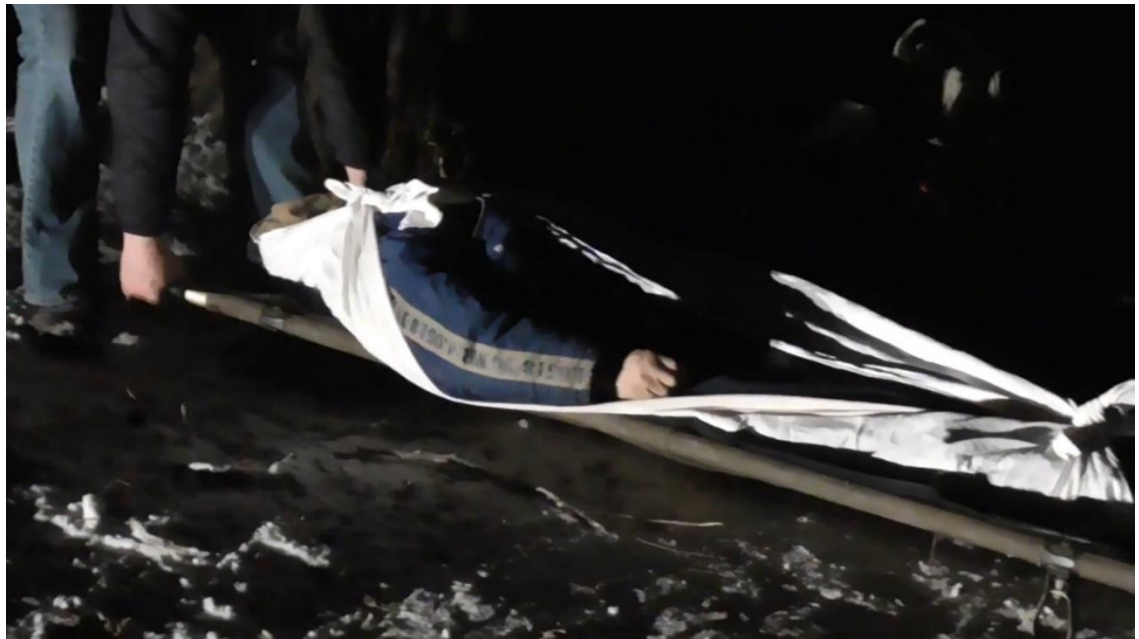
*Fig. 24 – The body of a man who died of shrapnel wounds a few meters from shell hit 14<sup>52</sup>.*

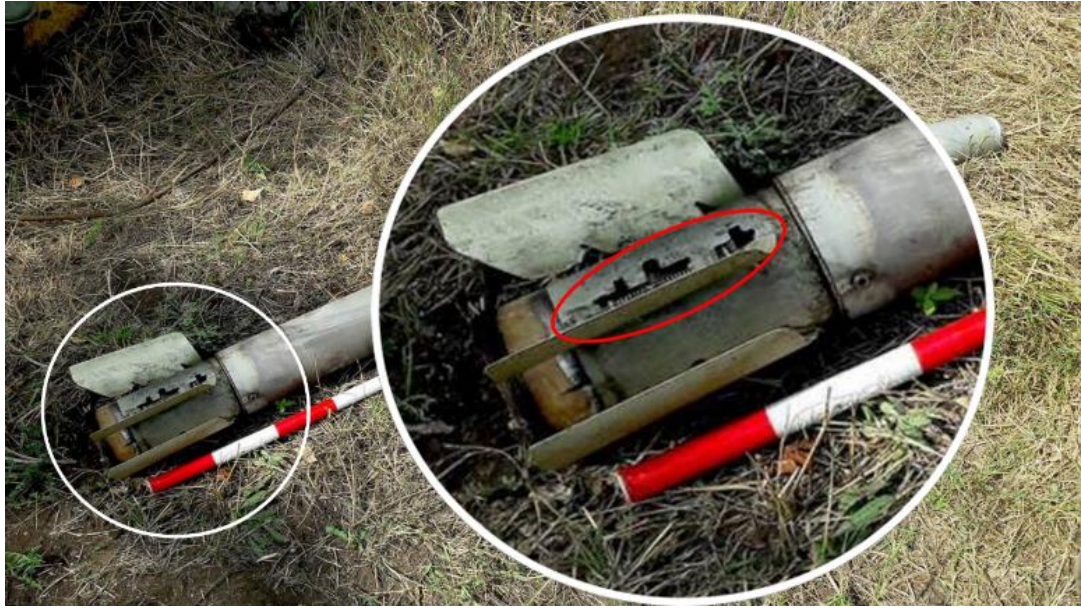
Fig. 25 – The remains of the 9K51 Grad MLRS projectile found near Krasnohorovka town on 28.08.2016.<sup>53</sup>
