# Shelling of the eastern residential Quarters of Luhansk with the use of Grad MLRS

## February 12, 2015.

*PUBLIC INVESTIGATION*

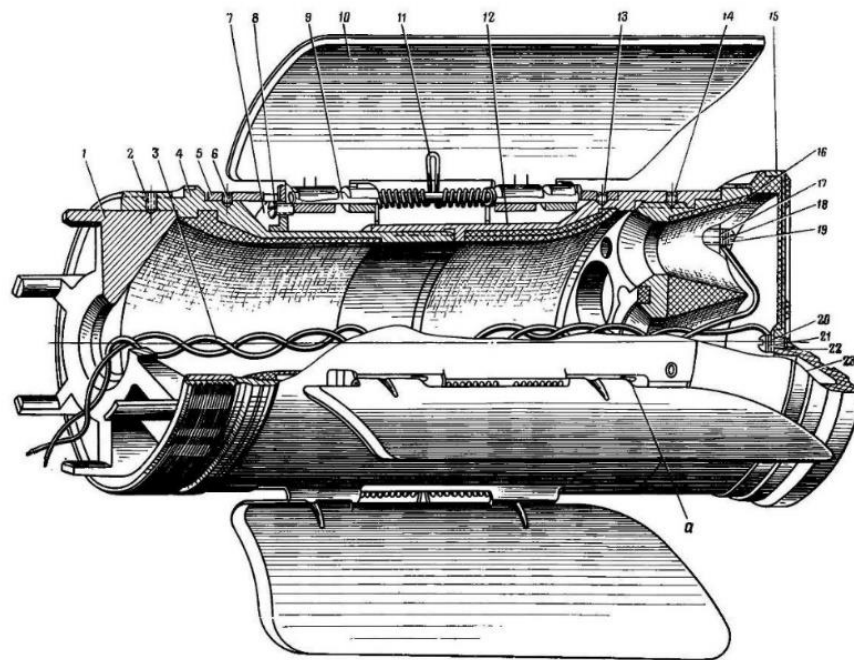
Рис. 101. Блок стабилизатора:  
 1 – хвостовая диафрагма; 2 – установочный винт; 3 – провод; 4 – передний конус; 5 – обтекатель; 6 – установочный винт; 7 – кольцо; 8 – винт; 9 – ось; 10 – довасть стабилизатора; 11 – пружина; 12 – задний конус; 13 – установочный винт; 14 – установочный винт; 15 – контактный сектор; 16 – крышка солено; 17 – шайба; 18 – пружинная шайба; 19 – контактный винт; 20 – шайба; 21 – пружинная шайба; 22 – контактный винт; 23 – контактная крышка; а – паз

Fig. 26 – The drawing of the 9K51 Grad MLRS projectile stabilizer unit from the book *BM-21 GRAD*<sup>54</sup>.

The rectangular shape of the holes for attaching the tail to the shell body is typical for the shells of the Uragan and Smerch MLRS<sup>9</sup>.

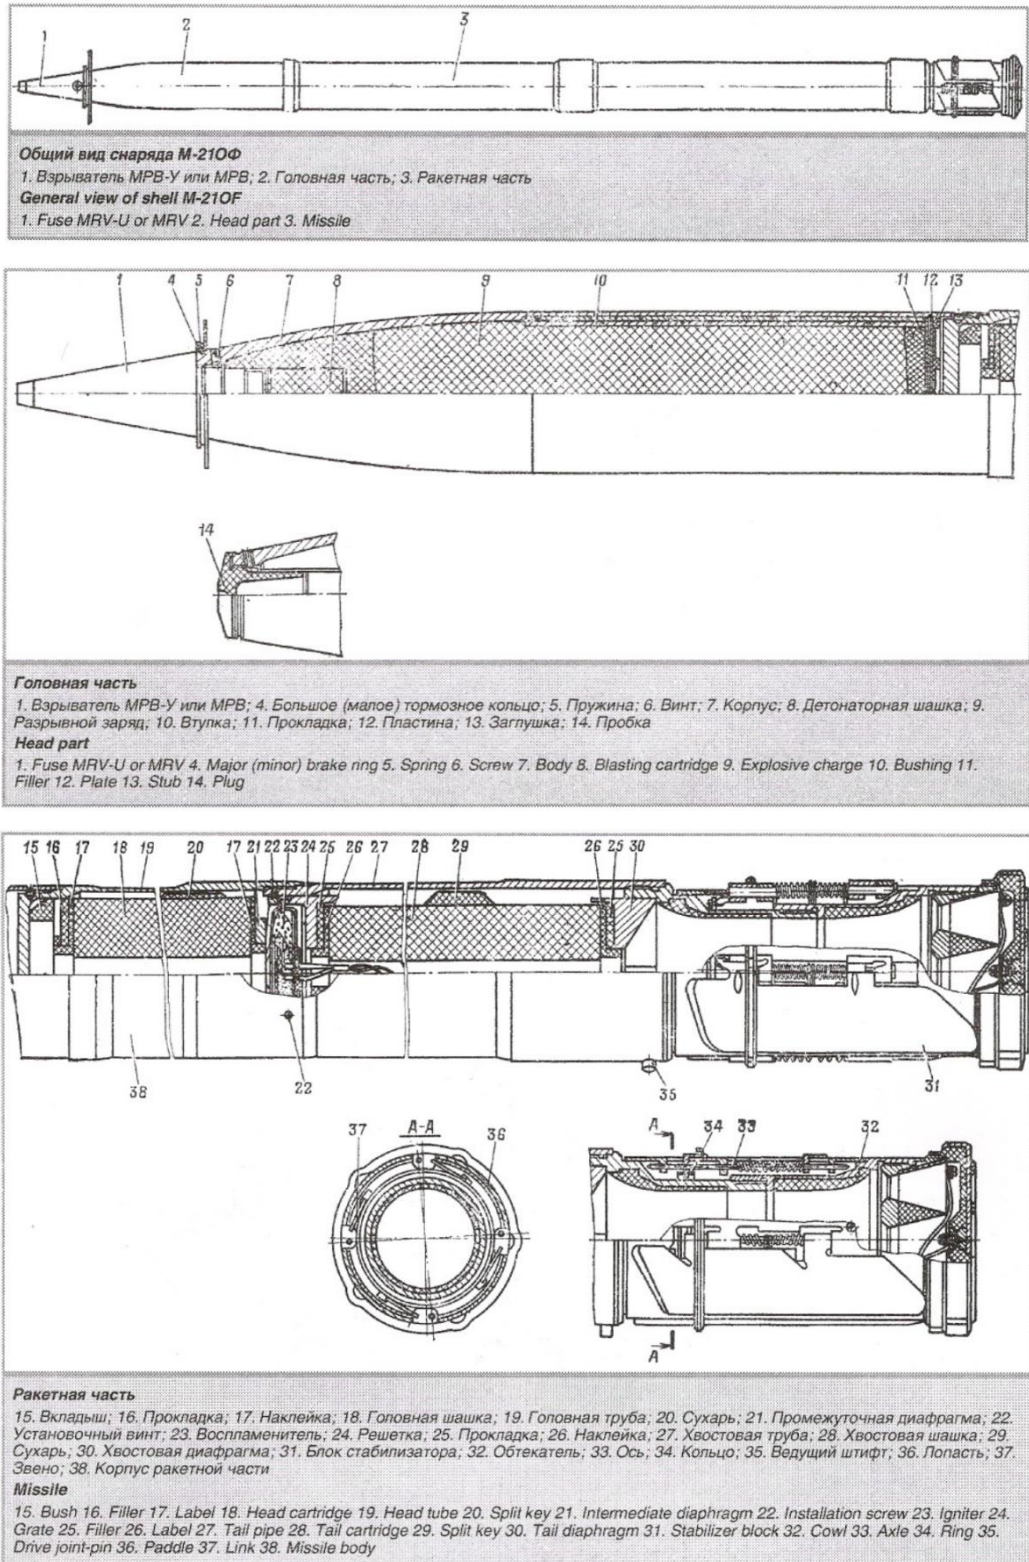
The projectile for firing from 9K51 Grad MLRS consists of a fuze, head and rocket parts. As a result of contact with an obstacle, the detonator initiates an explosion of the shell head, which scatters into fragments. The rocket often remains more or less intact, though deformed. It is usually found either inside the shell crater, or in the immediate vicinity of it. For clarity, we present the design and technical characteristics of the most common projectile used for firing from the 9K51 Grad MLRS (see Fig. 27, Fig. 28).

Fig. 27 - M-210F projectile design (a high explosive fragmentation projectile, used for firing from 9K51 Grad MLRS)<sup>55</sup>.

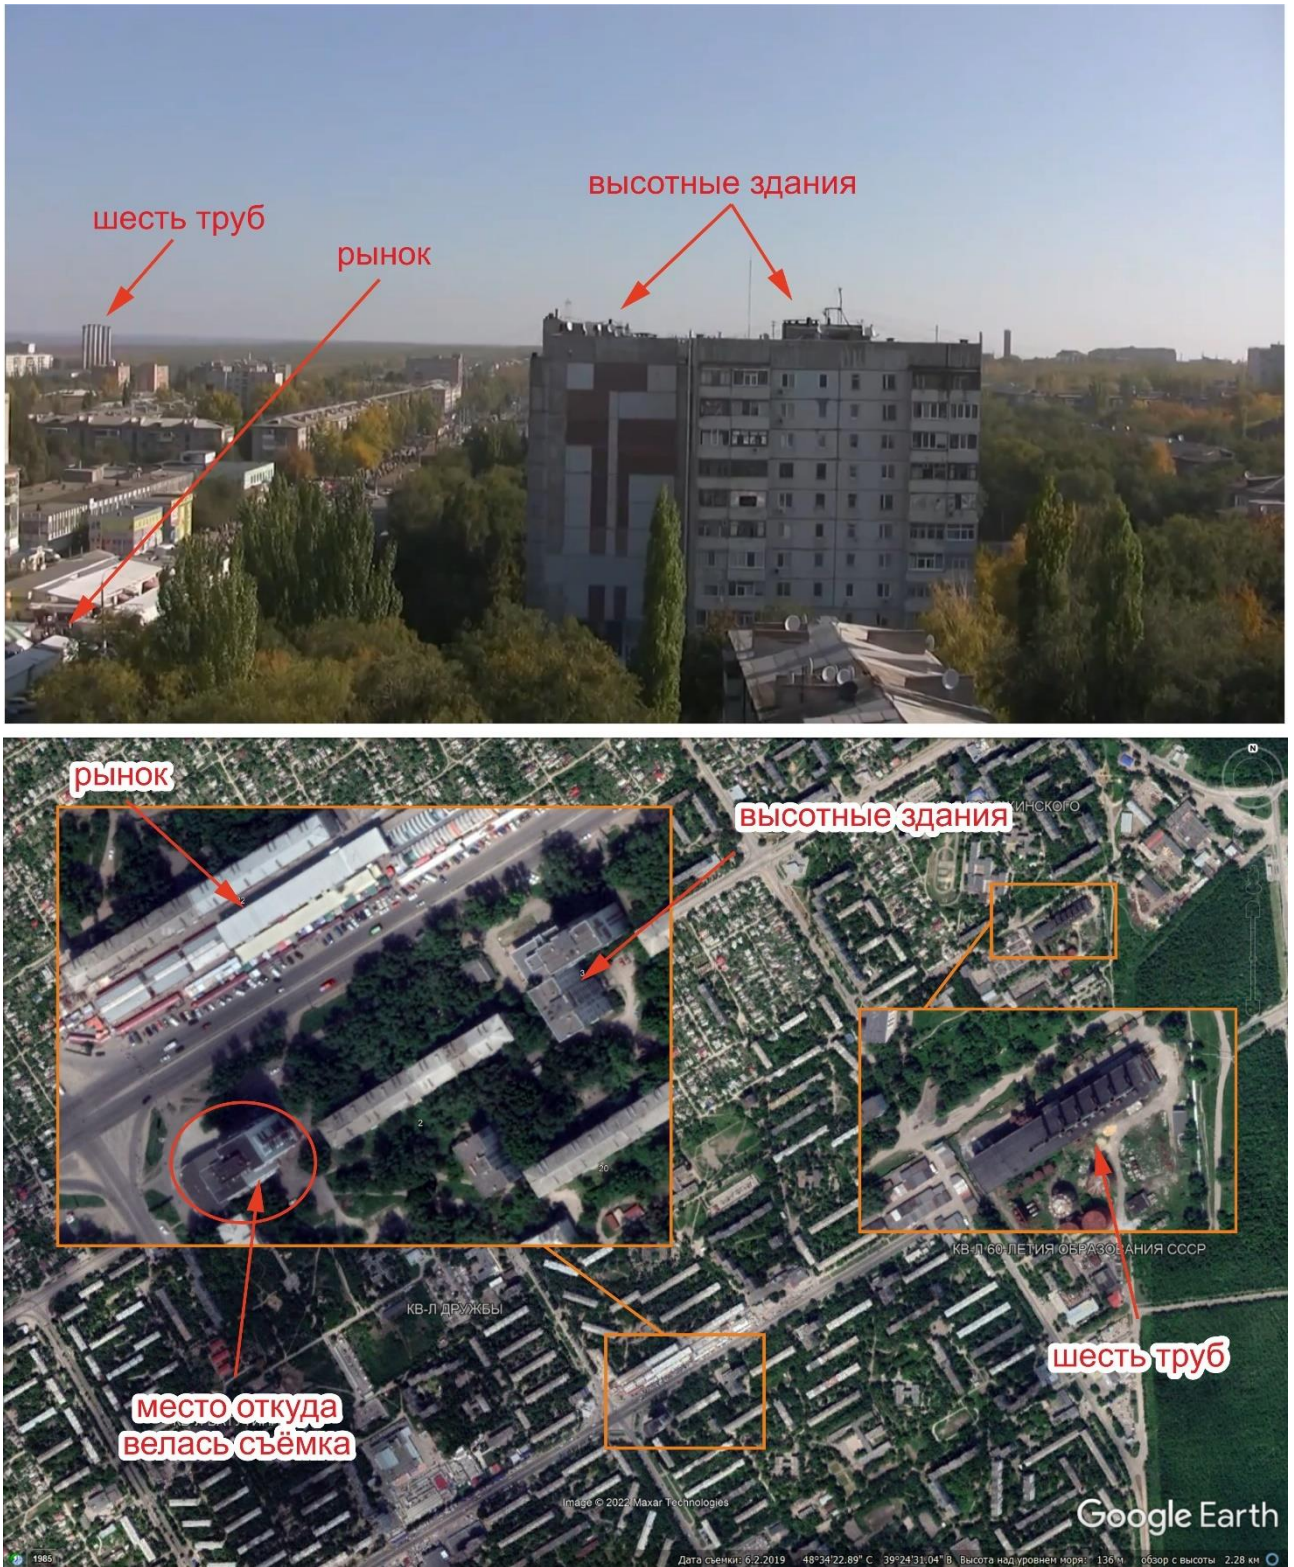
Fig. 29 – Determination of the place where the shooting was carried out.

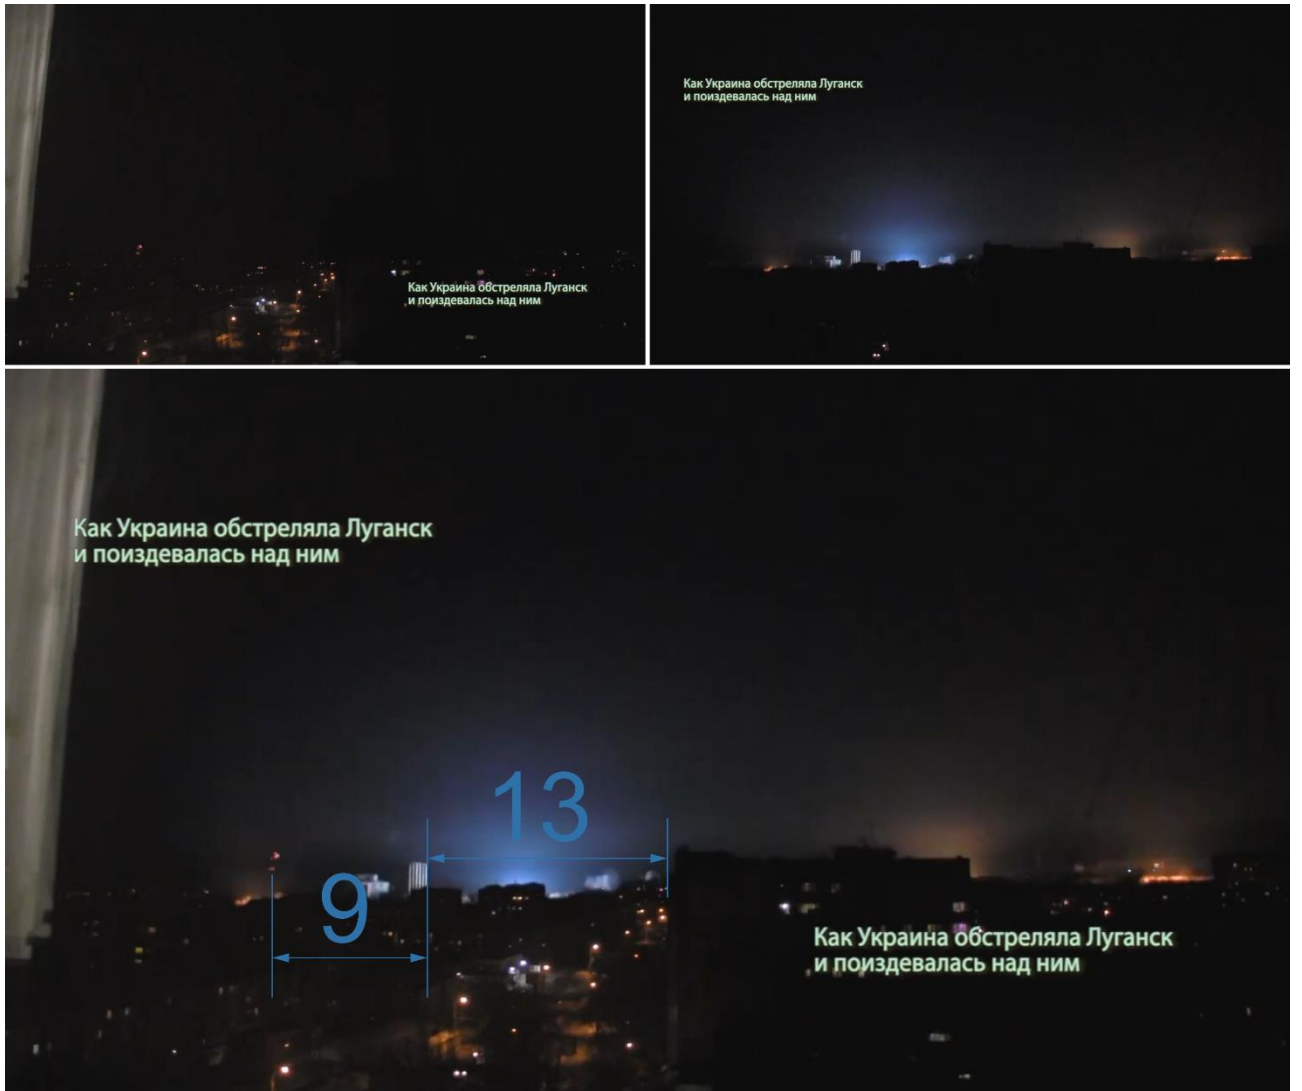
*Fig. 30 – Overlaying of frames to determine the location of the salvo relative to the silhouette of the city.*

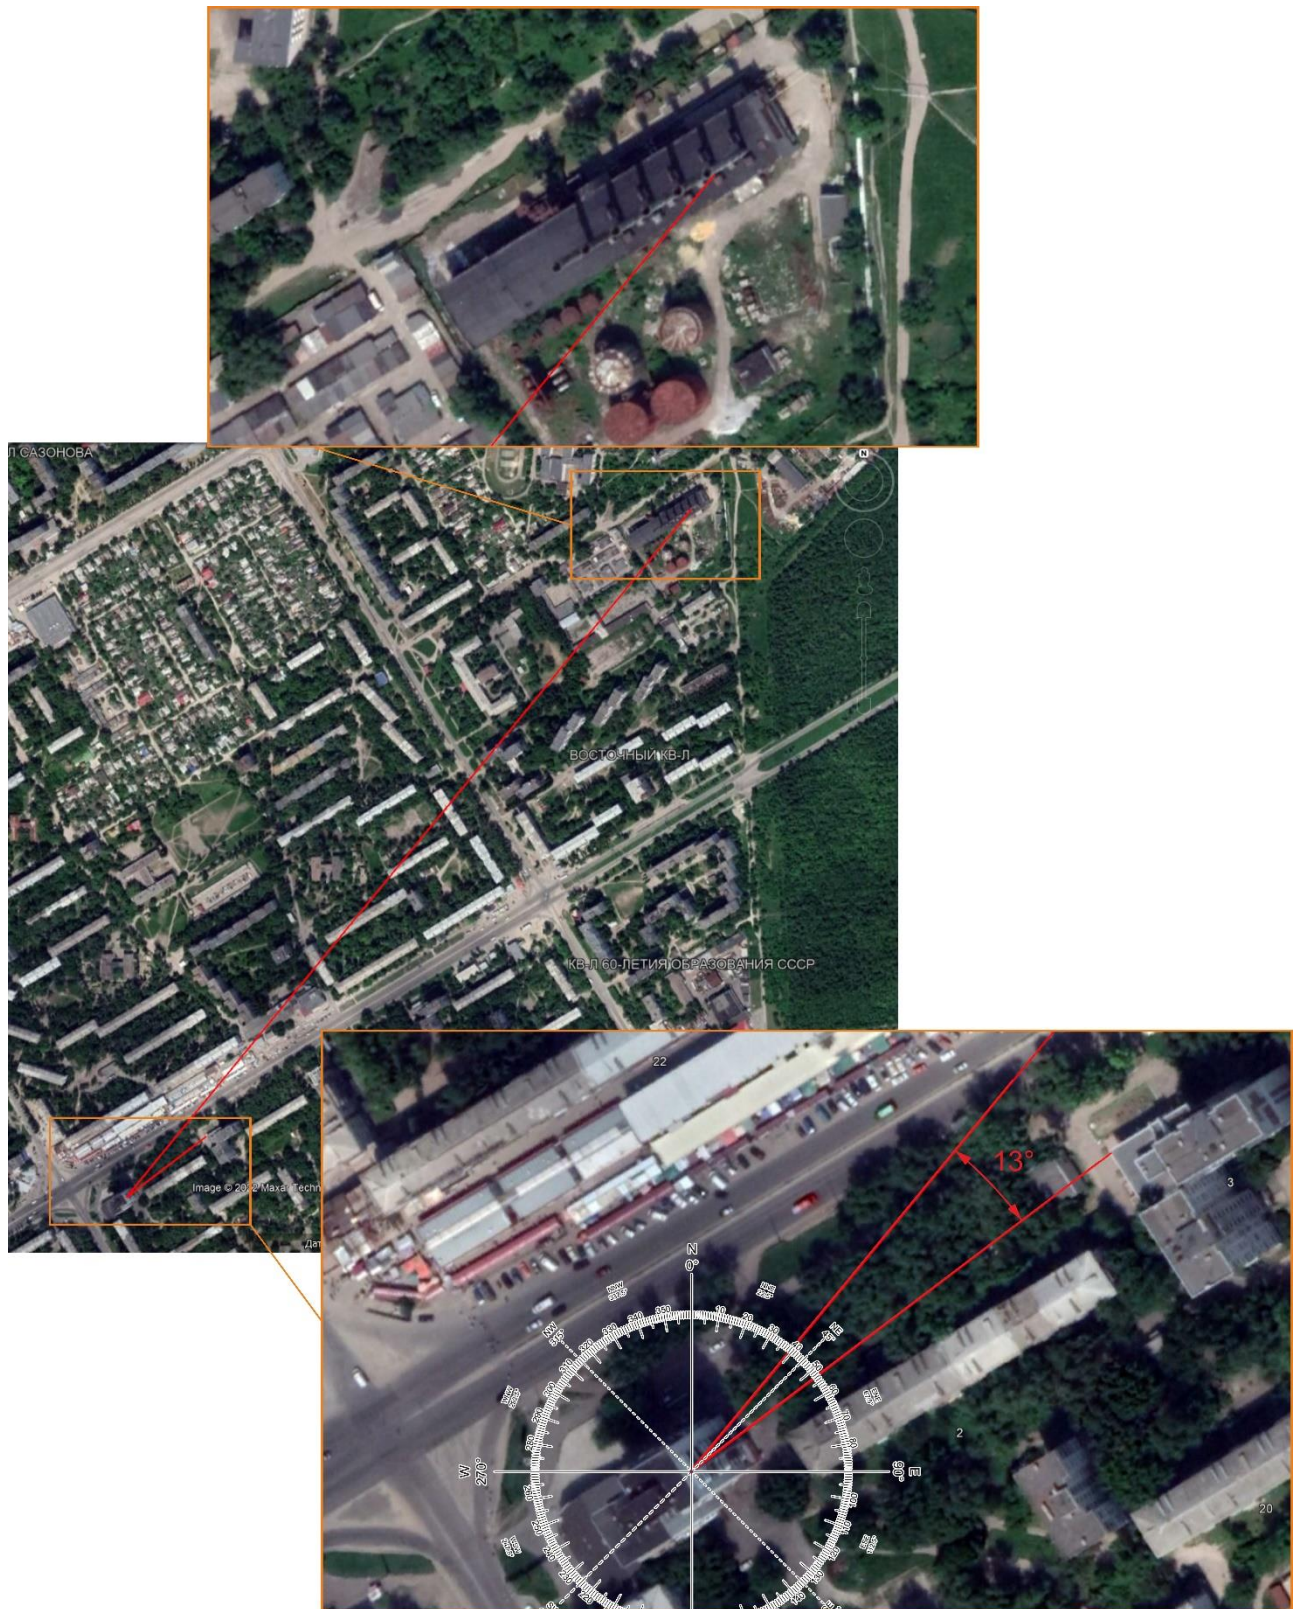
*Fig. 31 – Determination of the angle between the silhouette of high-rise buildings and the pipes of the boiler facility.*

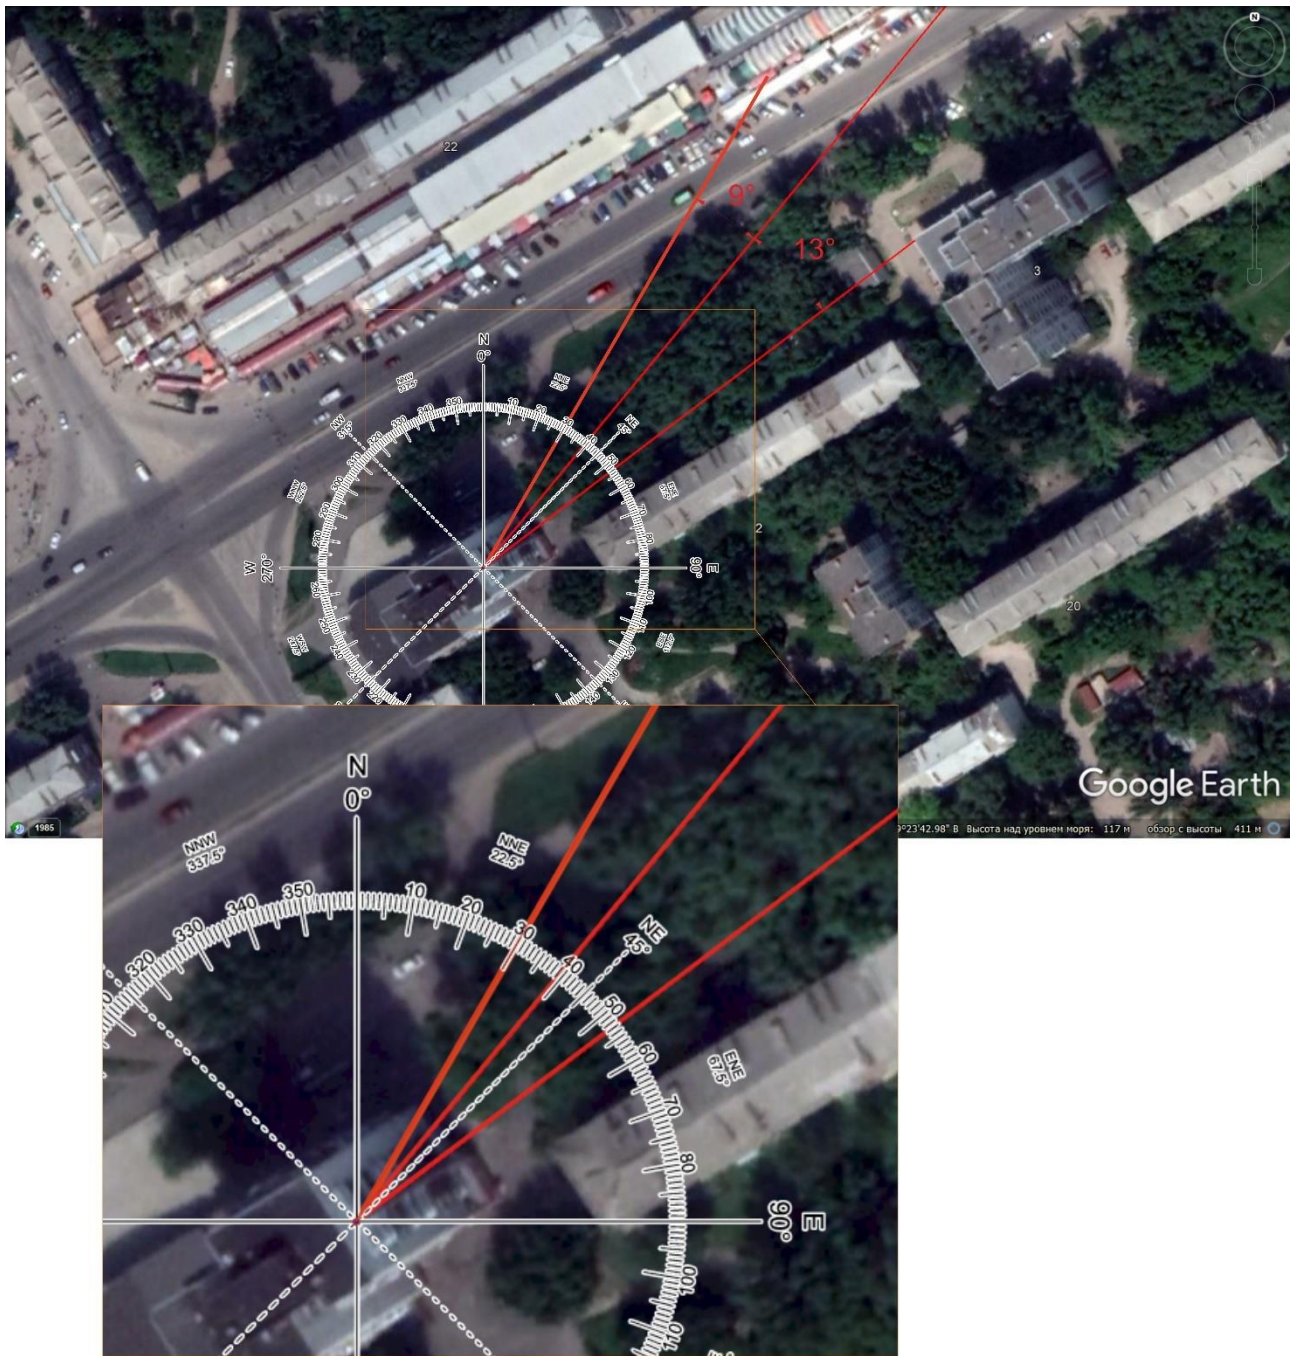
*Fig. 32 – Determination of the shelling direction.*

As noted above, the OSCE SMM determined that in the case under consideration in this investigation, Grad MLRS rockets were fired from the north - north-east.
