Shelling of the Mirny and Gayevoy residential quarters in the city of Luhansk with the use of Grad Multiple Launch Rocket Systems on July 14, 2014

PUBLIC INVESTIGATION

Donetsk 29.11.2021

Author: Ivan Aleksandrovich Kopyl

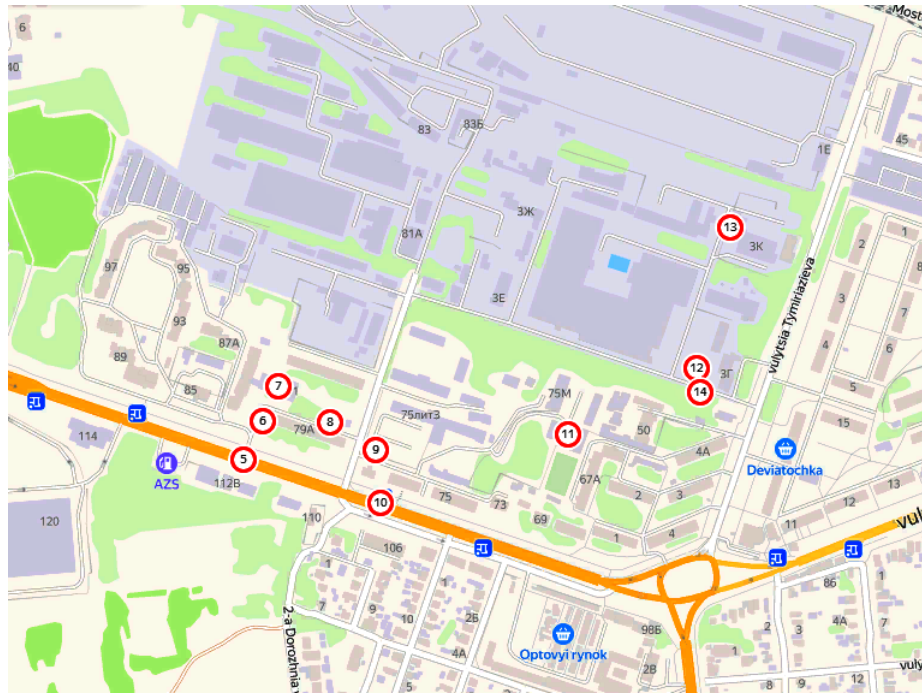
Fig. 2 - The scheme of shelling of the Mirny residential quarter, Luhansk, which happened on July 14, 2014 at about 18:00 (Moscow time).

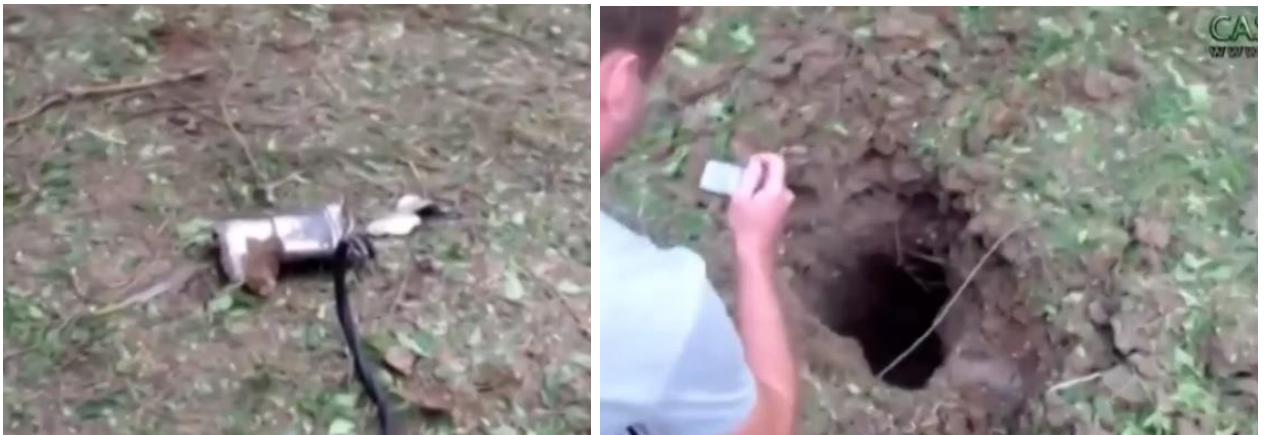
Fig. 3 - The scheme of shelling of the Gayevoy residential quarter, Luhansk, which happened on July 14, 2014 at about 18:00 (Moscow time).

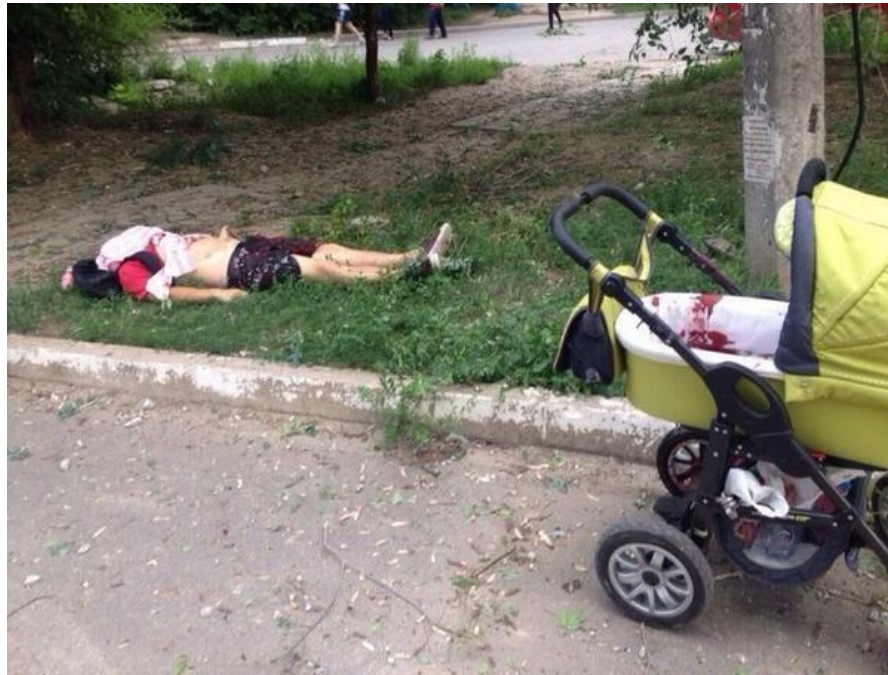
Shell hit 1 (see Fig. 4, see Fig. 5). The shell hit the lawn between the residential building at 2, Mirny quarter, Luhansk, and the "Karefan" café at 2 litZ, Mirny quarter. As a result of the detonation of this projectile, fatal injuries caused by shell fragments were received by a young mother who was walking with a child and Nikolai Bakhmach⁵.

Fig. 4 – The shell that fell between the building in 2, Mirny Kvartal, Luhansk, and the “Karefan” cafe¹⁶.

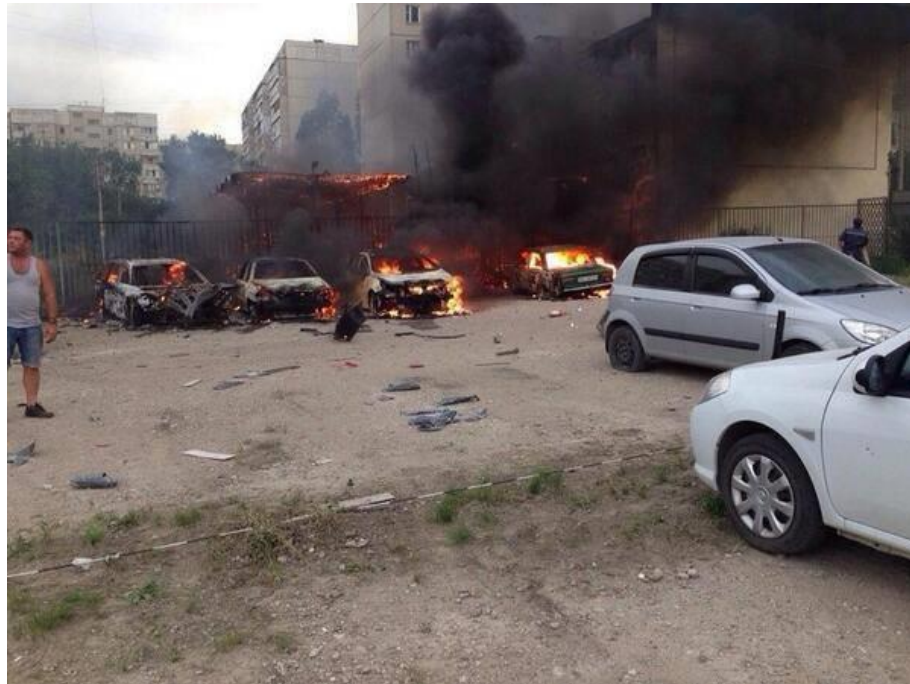
Shell hit 2 (see Fig. 6). The shell hit the territory of the parking lot, which is adjacent to the north side of the "Karefan" café. As a result of the projectile detonation, several motor vehicles started burning.

Fig. 6 – Burning cars in the parking lot, which is adjacent to the north side of the “Karefan” café after being hit by a projectile¹⁸.

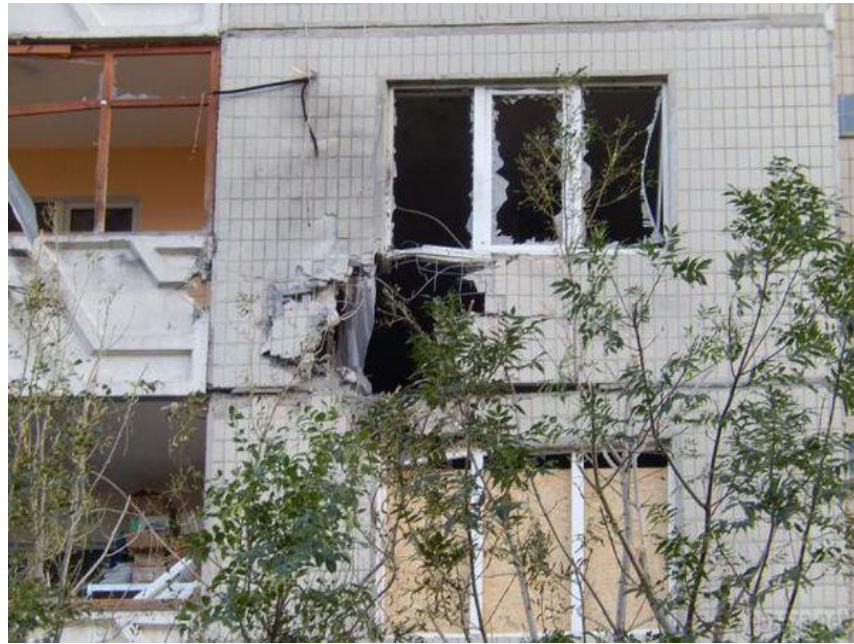
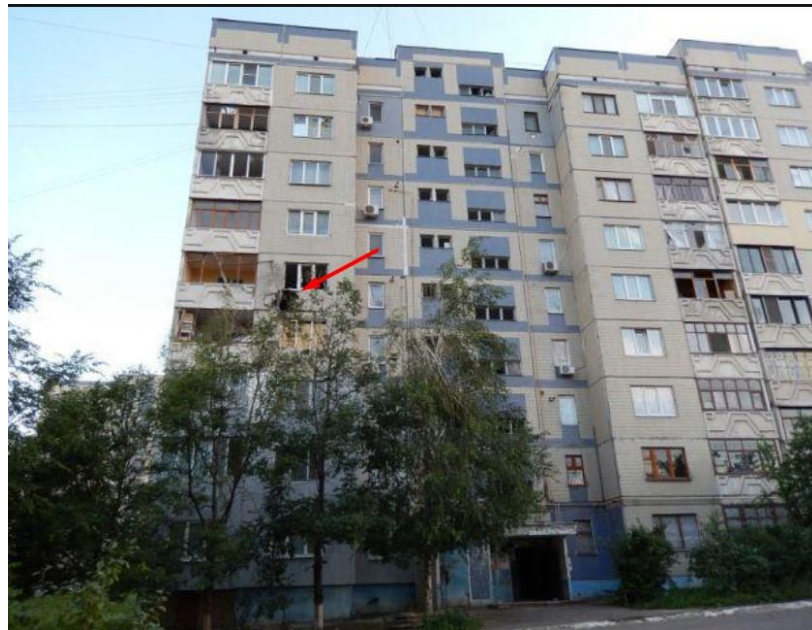
Shell hit 3 (see Fig. 7, see Fig. 8) A shell hit the northern wall of a multi-storey residential building at the address 6, Stepnoy quarter, Luhansk, at the second-floor level. As a result of the projectile detonation, a through hole was formed in the wall of the building.

Fig. 7 – A shell hit on the northern wall of a multi-storey residential building at the address 6, Stepnoy quarter, Luhansk, at the fourth-floor level¹⁹.

Fig. 8 - A shell hit on the northern wall of a multi-storey residential building at the address 6, Stepnoy quarter, Luhansk, at the fourth-floor level²⁰.

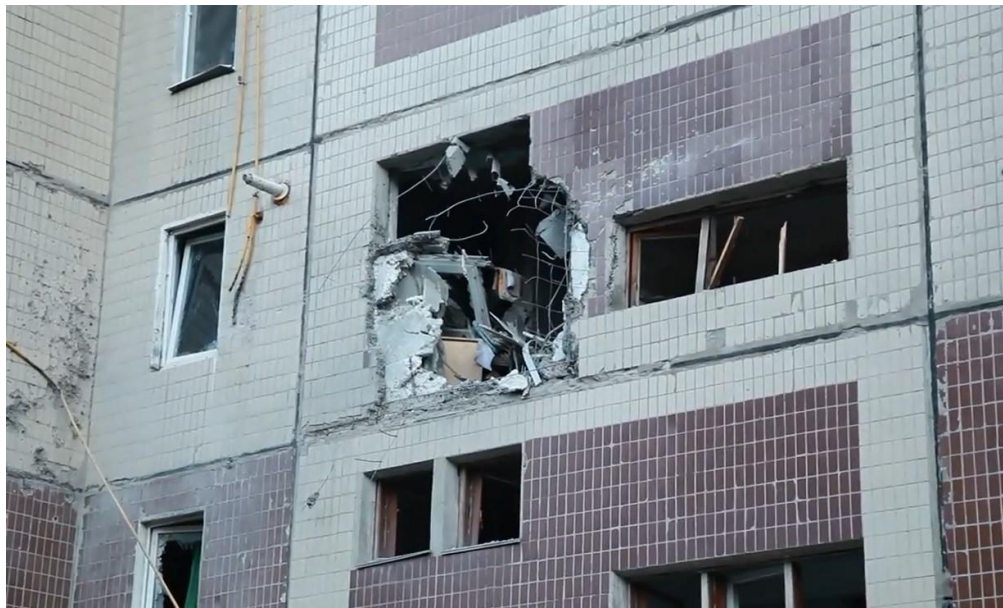
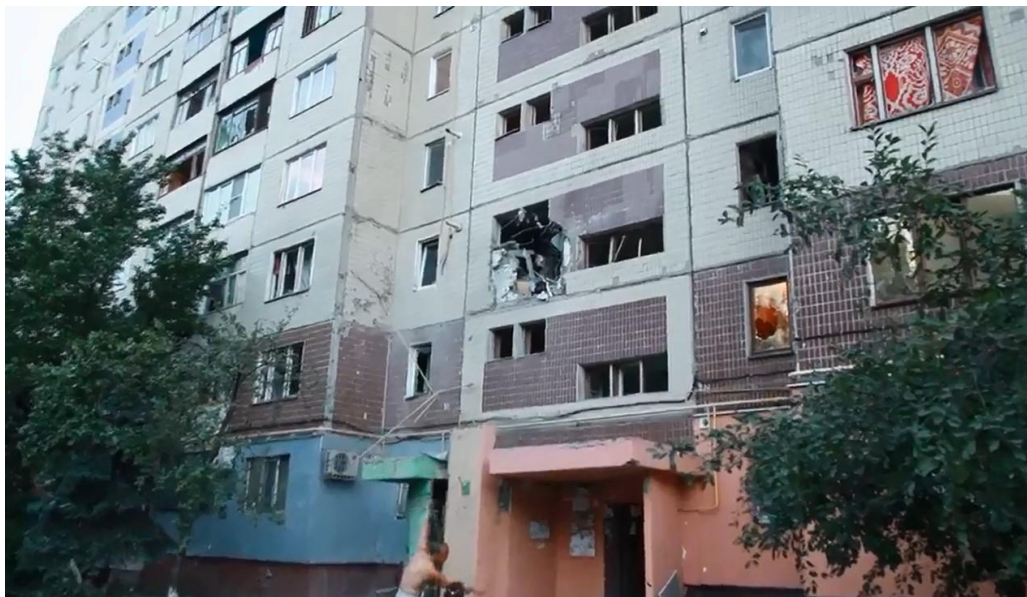
Shell hit 4 (see Fig. 9, see Fig. 10, see Fig. 11) A shell hit the northern wall of a multi-storey residential building at the address 16, Stepnoy quarter, Luhansk, at the second-floor level. As a result of the projectile detonation, a through hole was formed in the wall of the building.

Fig. 9 – A hole formed as a result of the projectile-initiated detonation in the northern wall of a multi-storey residential building at the address 16, Olkhovsky quarter, Luhansk, at the second floor level²¹.

Fig. 10 - A hole formed as a result of the projectile-initiated detonation in the northern wall of a multi-storey residential building at the address 16, Olkhovsky quarter, Luhansk, at the second floor level²²

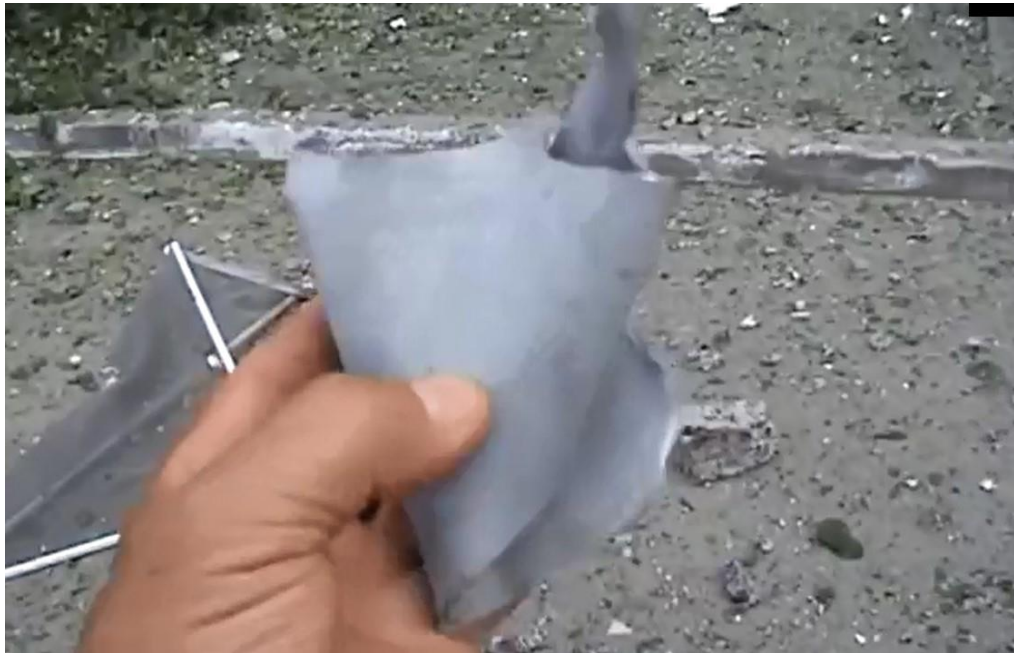
Fig. 11 - A shell fragment found near the projectile detonation site beside the residential building at the address 16, Olkhovsky quarter, Luhansk²³.

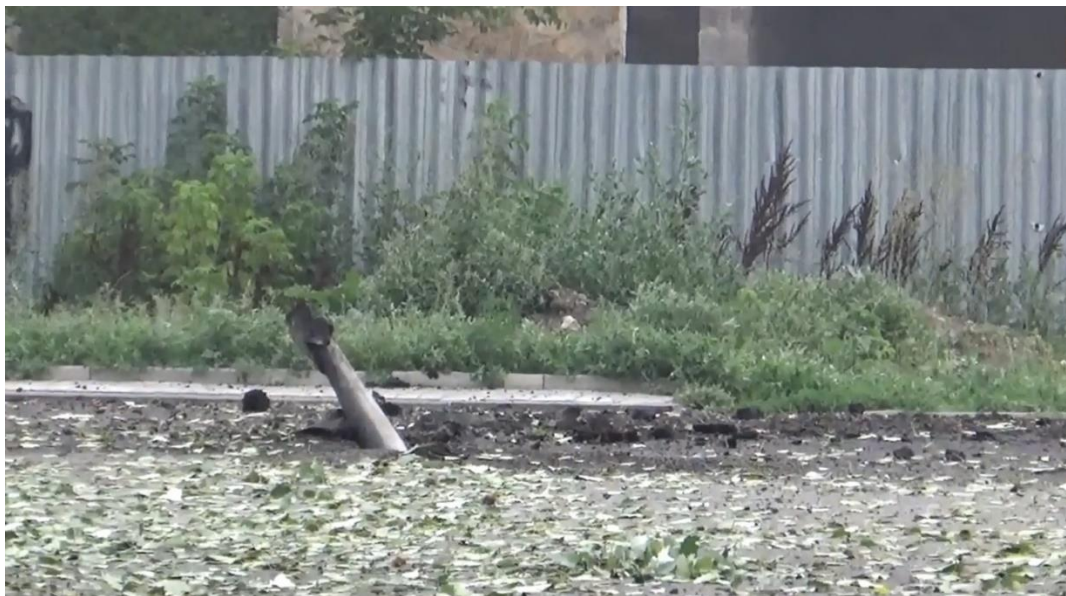
Fig. 12). A shell hit the road pavement at the exit from Andrey Linyov Street, opposite the western end of the residential building at 79A, Andrey Linyov St, Luhansk. The projectile detonation resulted in a shell crater.

Fig. 12 - Debris of the projectile missile part in the road pavement at the exit from Andrey Linyov Street, opposite the western end of the residential building at 79A, Andrey Linyov St, Luhansk²⁴.

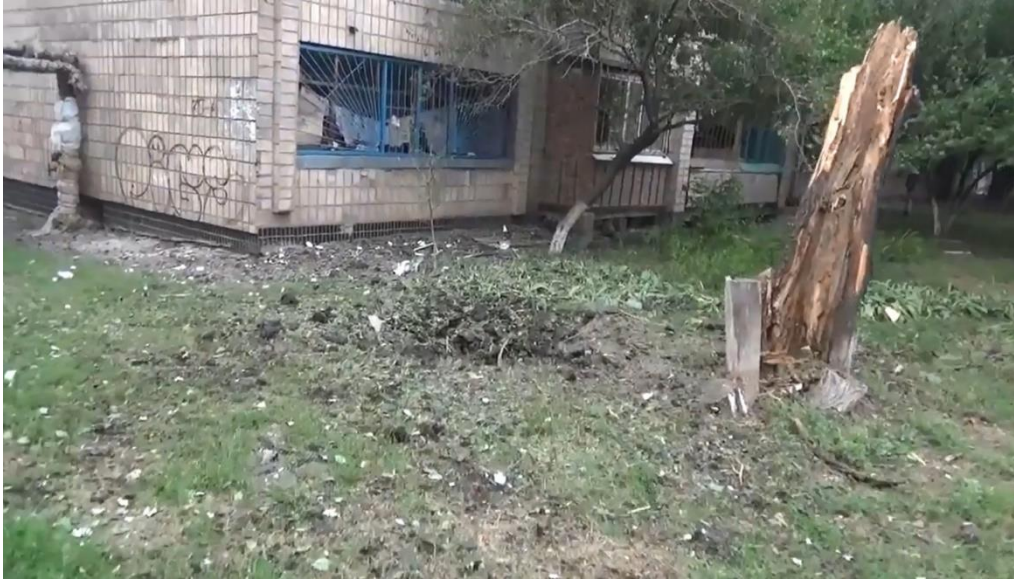
Shell hit 6 (see Fig. 13) A shell hit a lawn a few meters from the south-western corner of a multi-storey residential building at 79A, Andrey Linyov St, Luhansk. The projectile detonation resulted in a shell crater.

Fig. 13 - An artillery shell explosion crater on a lawn a few meters from the south-western corner of a multi-storey residential building at 79A, Andrey Linyov St, Luhansk²⁵.

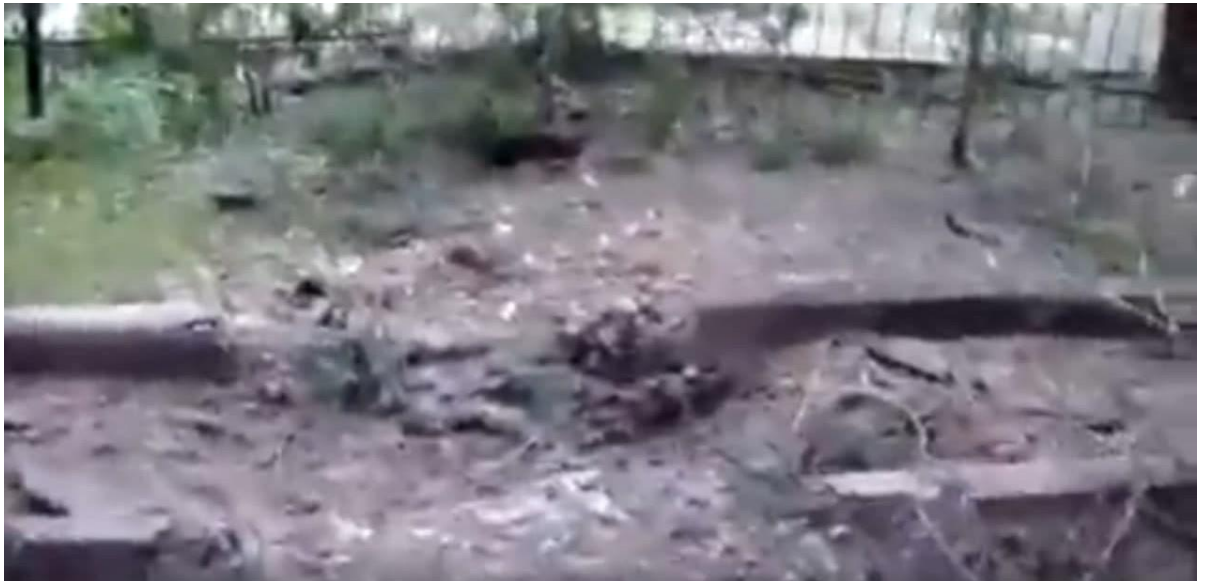
Shell hit 7 (see Fig. 14) A shell hit the curb of the sidewalk between residential buildings at 85A, Andrey Linyov St. and 81, Andrey Linyov St. The projectile detonation resulted in a shell crater.

Fig. 14 - Shell hit on the curb of the sidewalk between residential buildings at 85A, Andrey Linyov St. 81, Andrey Linyov St²⁶.

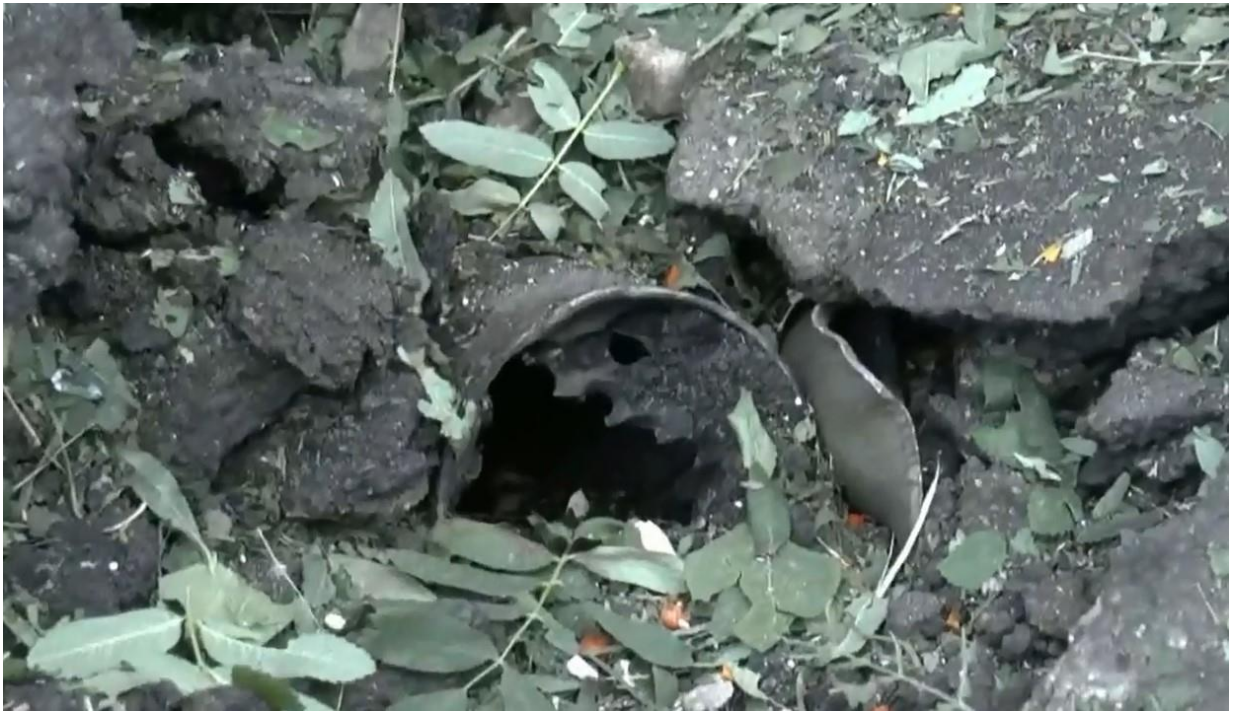
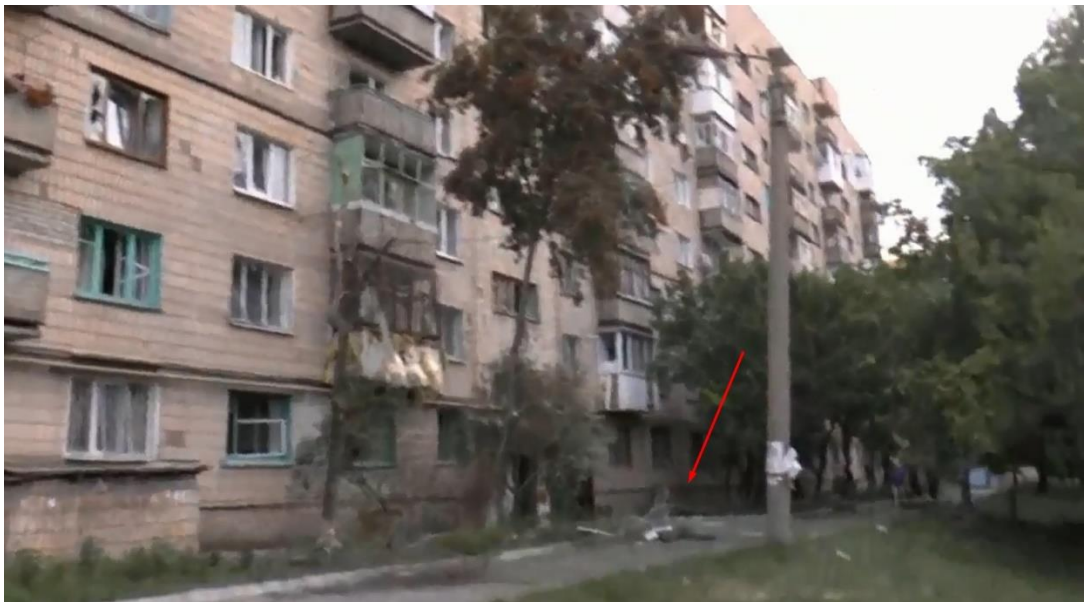
Shell hit 8 (see Fig. 15, see Fig. 16) A shell hit the ground a few meters north of the residential building at 79A, Andrey Linyov St., Luhansk between 1 and 2 entrance halls. The projectile detonation resulted in a shell crater in the yard.

Fig. 15 - Debris of the projectile missile part a few meters north of the residential building at 79A, Andrey Linyov St., Luhansk between 1 and 2 entrance halls.²⁷

Fig. 16 – A crater in the yard of a multi-storey residential building at 79A, Andrey Linyov St., Luhansk, between 1 and 2 entrance halls²⁸.

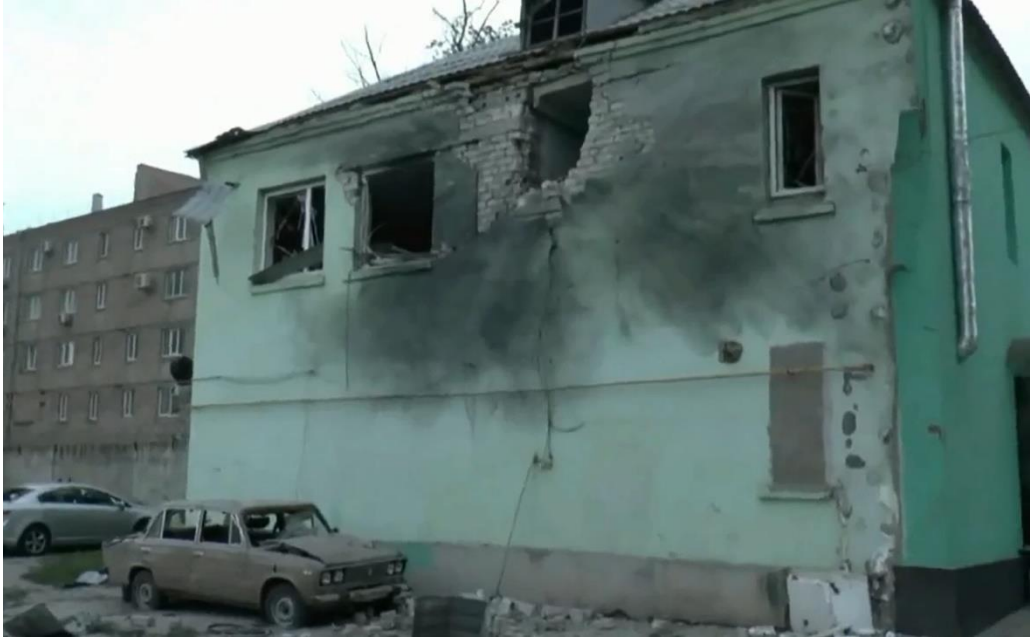
Shell hit 9 (see Fig. 17) A shell hit the northern wall of the two-storey residential building at 75L, Andrey Linyov St., Luhansk, at the level of the 1st floor. As a result of the projectile detonation, a through hole was formed in the wall of the building.

Fig. 17 – A hole formed as a result of the projectile-initiated detonation in the northern wall of the two-storey residential building at 75L, Andrey Linyov St., Luhansk, at the level of the 1st floor.²⁹

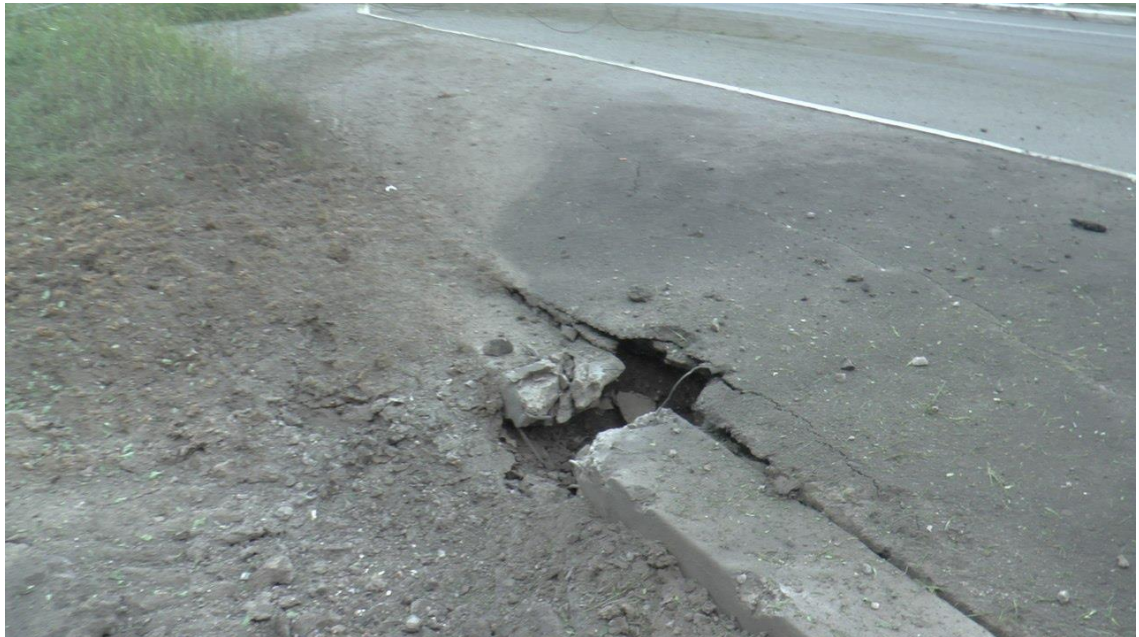
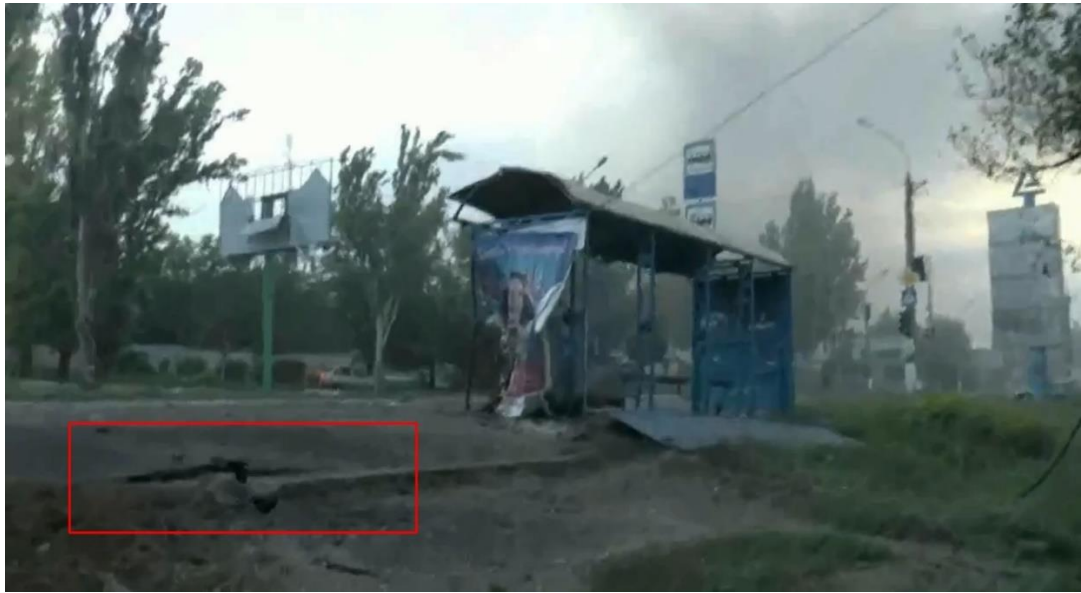
Shell hit 10 (see Fig. 18, see Fig. 19, see Fig. 20) A shell hit a curb in the northern part of the road next to the “Vtorchermet” public transport stop, which is located to the south of the residential building at 77, Andrey Linyov St., Luhansk. As a result of the projectile detonation an unknown man was killed at a public transport stop, and a crater was formed in the curb stone.

Fig. 18 - A crater from the explosion of an artillery shell in a curb in the northern part of the road next to the “Vtorchermet” public transport stop, which is located to the south of the residential building at 77, Andrey Linyov St, Luhansk³⁰.

Fig. 19 - A crater from the explosion of an artillery shell in a curb in the northern part of the road next to the “Vtorchermet” public transport stop, which is located to the south of the residential building at 77, Andrey Linyov St, Luhansk³¹.

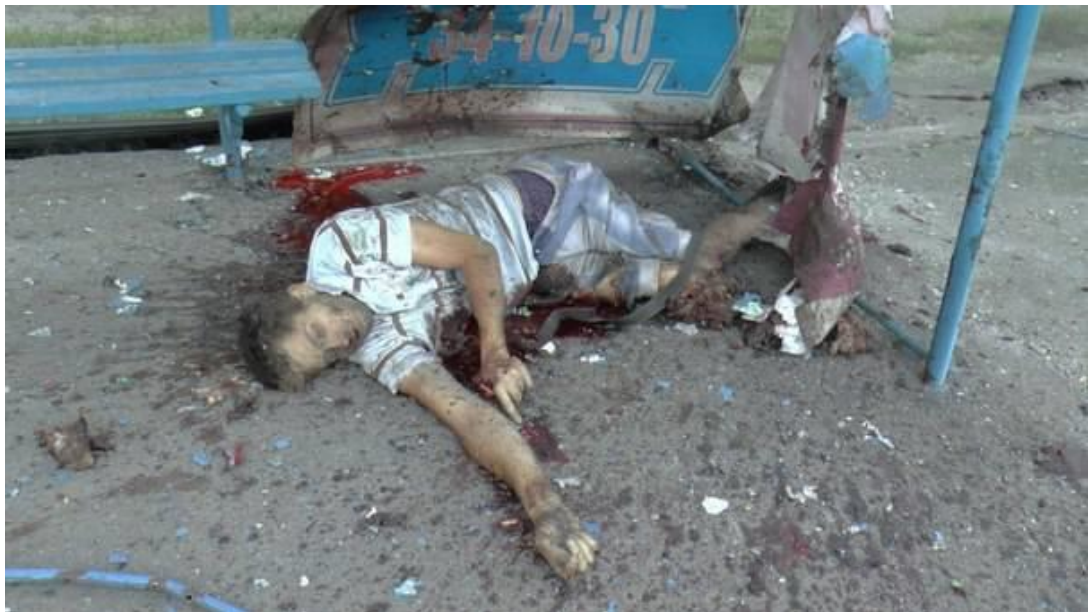
Fig. 20 – The body of a man who was killed at the “Vtorchermet” public transport stop located to the south of the residential building at 77, Andrey Linyov St., Luhansk³².

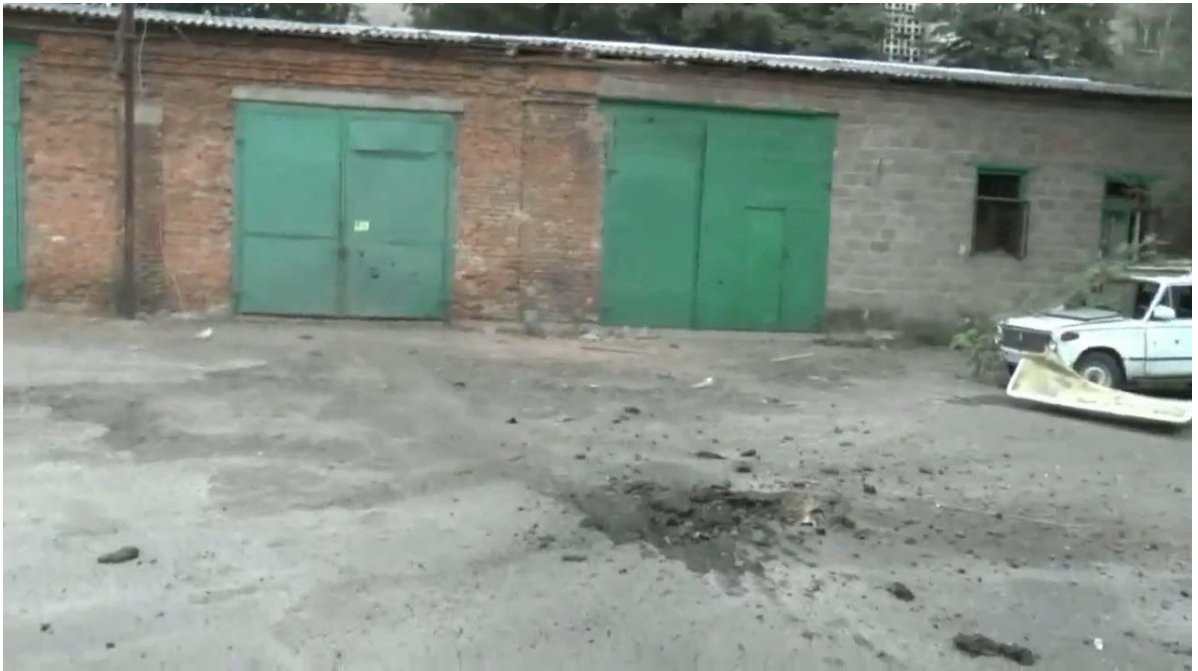
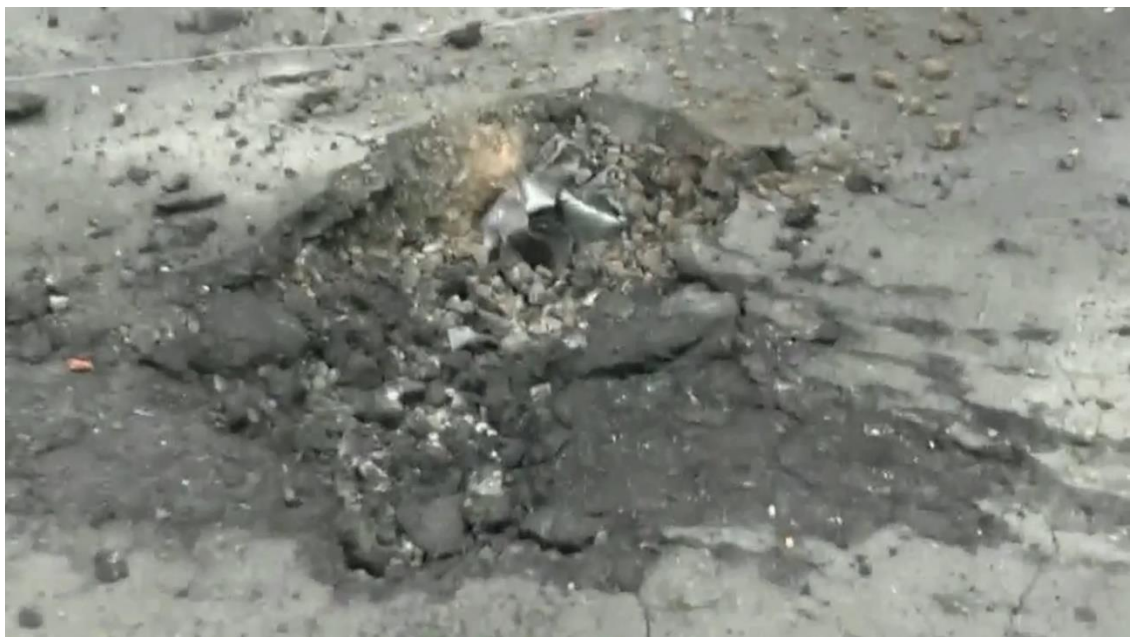
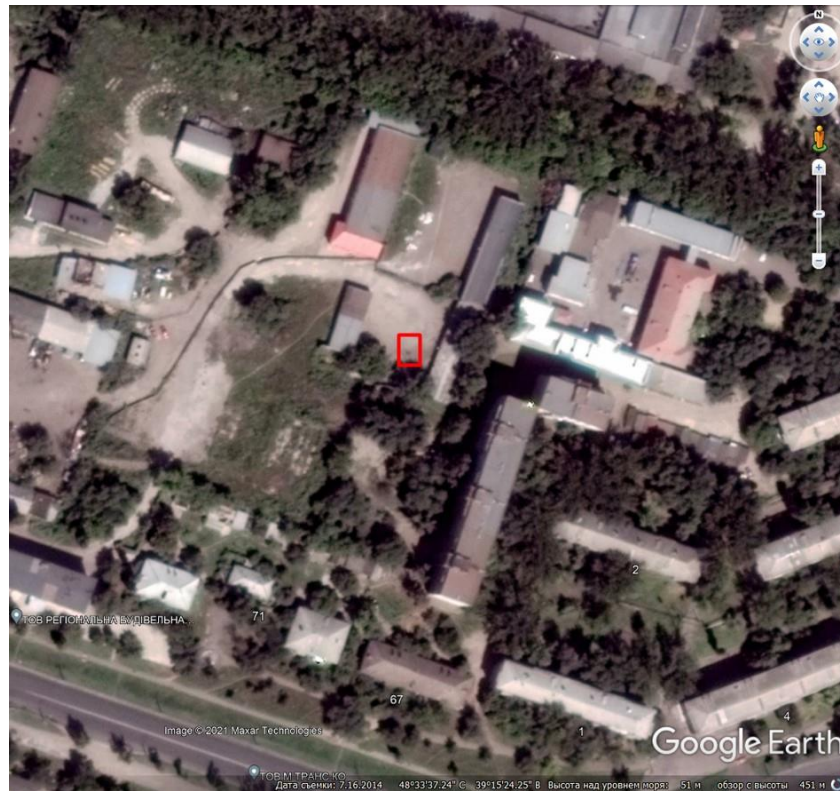
Shell hit 11 (see Fig. 21, see Fig. 22, see Fig. 23) A shell hit the asphalt pavement nearby garages. A crater was formed 45 meters south of the south-east corner of the building at 75M, Andrey Linyov St., Luhansk.

Fig. 21 - A crater located 45 meters south of the south-east corner of the building at 75M, Andrey Linyov St., Luhansk³³.

Fig. 22 - Debris of the projectile missile part in the crater located 45 meters south of the south-east corner of the building at 75M, Andrey Linyov St., Luhansk³⁴.

Fig. 23 - The trail of a shell hit in the asphalt pavement nearby garages. A crater was formed 45 meters south of the south-east corner of the building at 75M, Andrey Linyov St., Luhansk, satellite image dated 16.07.2014.

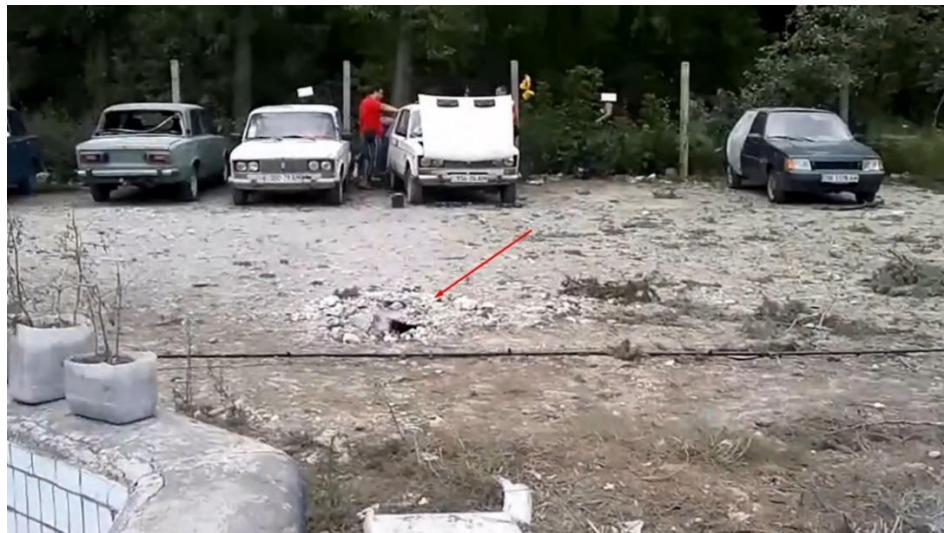
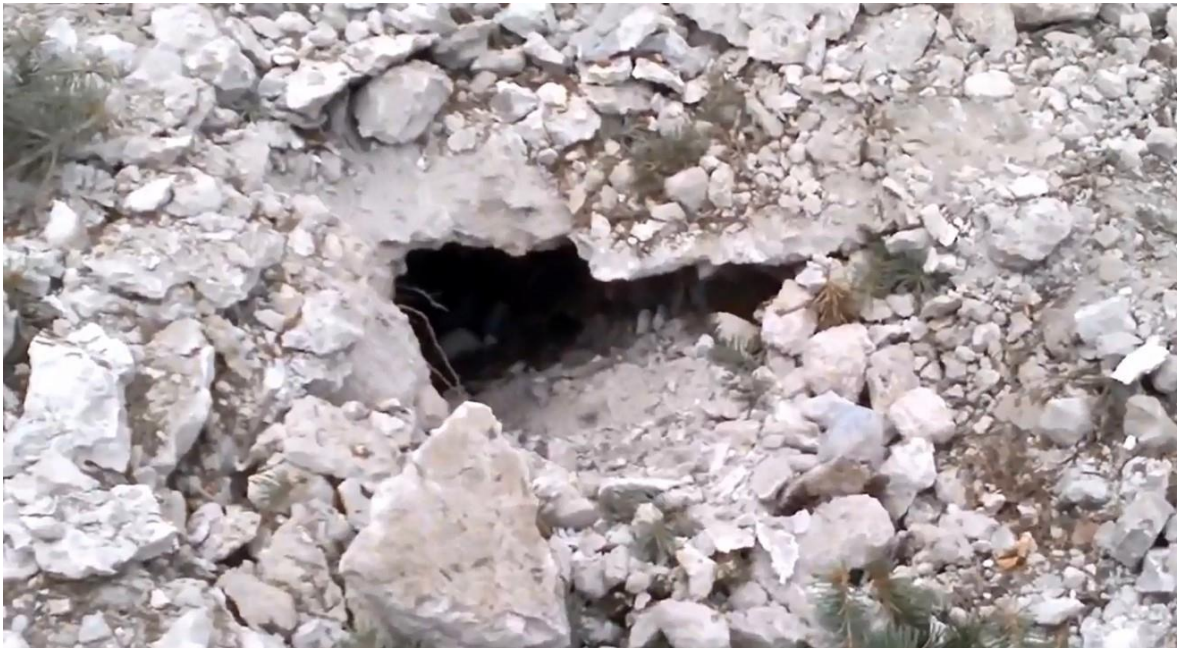
Shell hit 12 (see Fig. 24, see Fig. 25) A shell hit the car parking lot to the west of the residential building at 3G, Timiryazev St., Luhansk. As a result of the projectile detonation, several motor vehicles started burning.

Fig. 24 - A crater from the shell in the car parking to the west of the building at 3G Timiryazev St., Luhansk³⁵.

Fig. 25 – A crater from the shell in the car parking to the west of the building at 3GTimiryazev St., Luhansk³⁶.

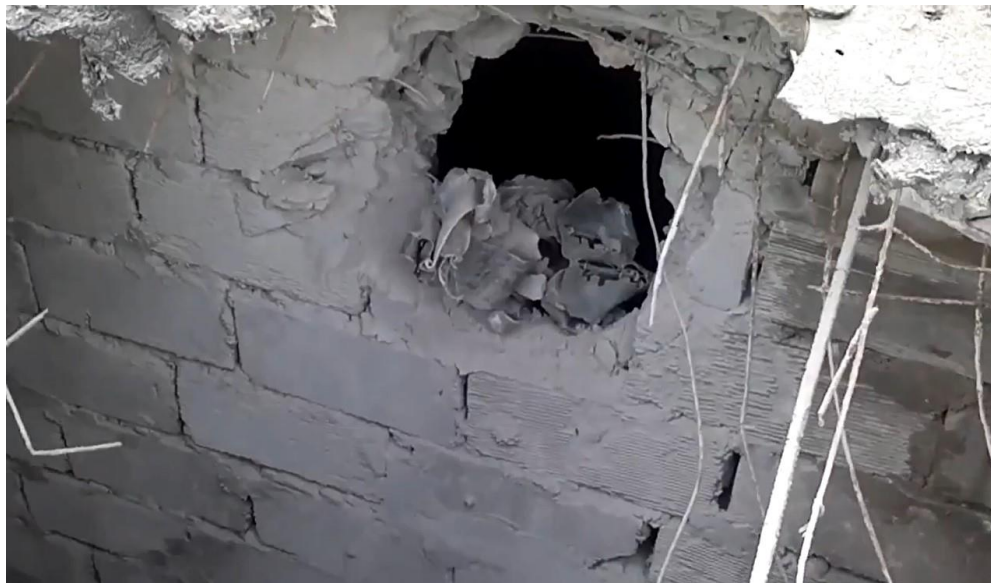
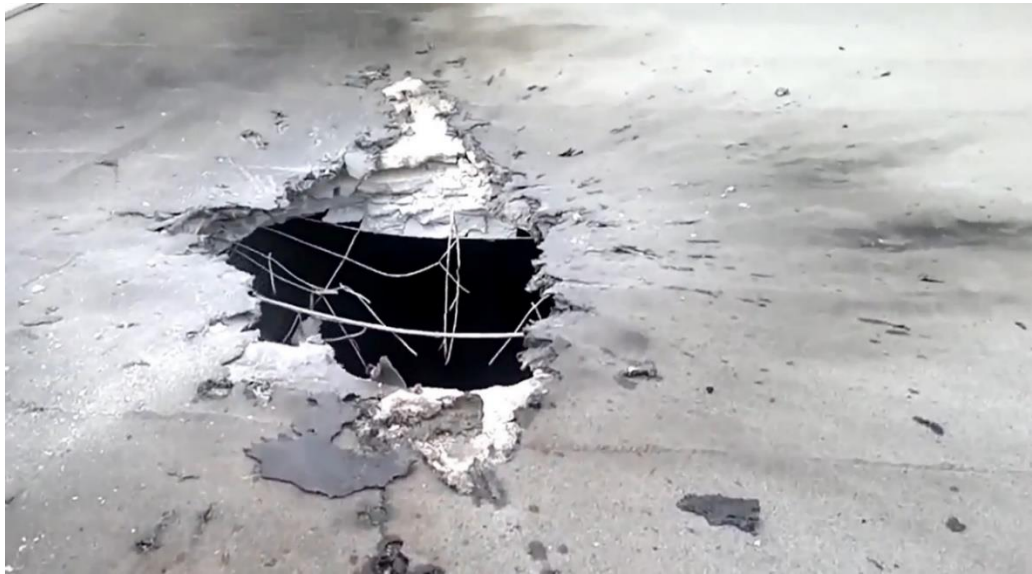
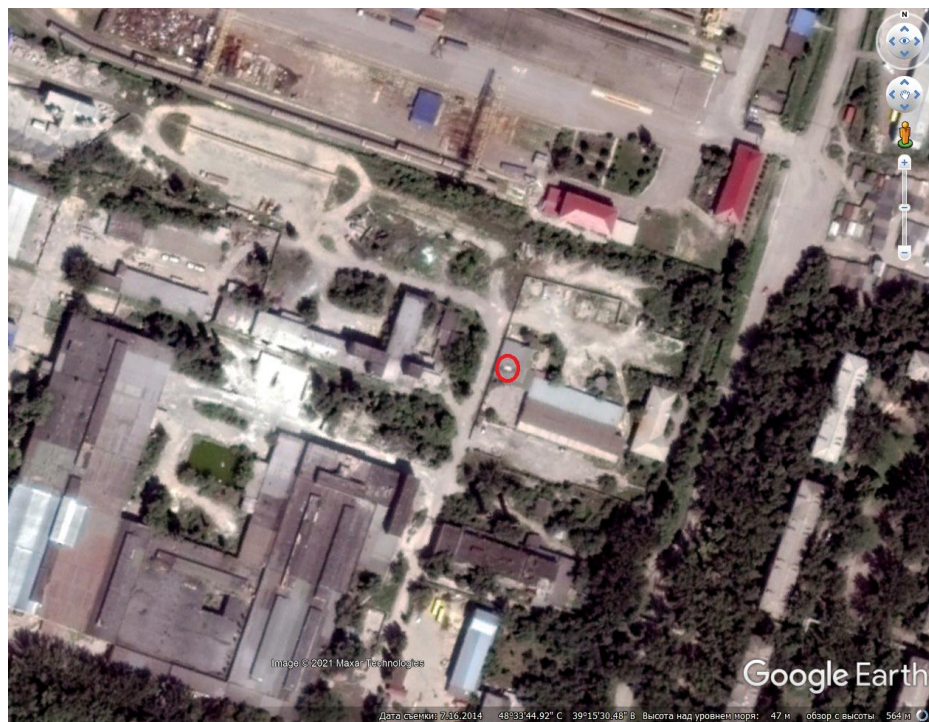
Shell hit 13 (see Fig. 26, see Fig. 27, see Fig. 28) A shell hit the roof of the utility premises located to the north of the building at the address 75 lit. Z, Andrey Linyov St., Luhansk. As a result of the projectile detonation, a through hole was formed in the roof.

Fig. 26 – A hole cut off as a result of the projectile detonation in the inner wall of the utility premises located to the north of the building at the address 75 lit Z, Andrey Linyov, Luhansk³⁷.

Fig. 27 – A hole broken by a projectile in the roof of the utility premises located to the north of the building at the address 75 lit. Z, Andrey Linyov St., Luhansk³⁸.

Fig. 28 – Trail of the shell hit into the roof of the utility premises located to the north of the building at the address 75 lit Z, Andrey Linyov St., Luhansk, satellite image dated 16.07.2014.

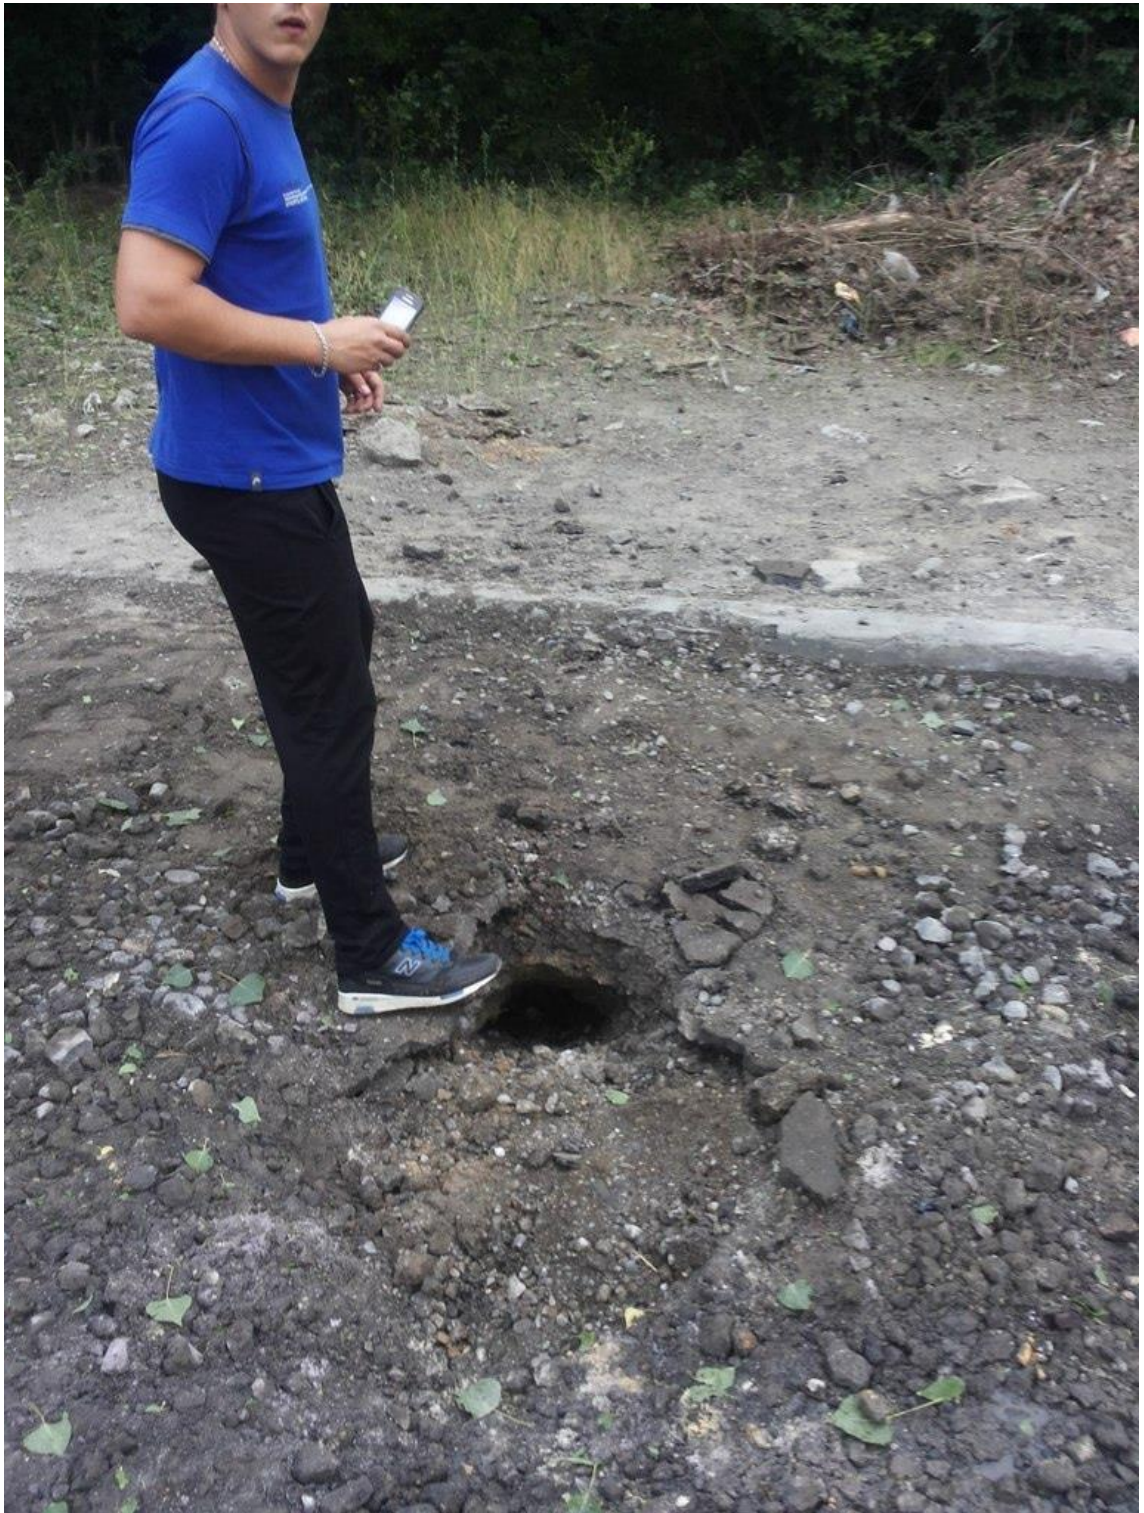
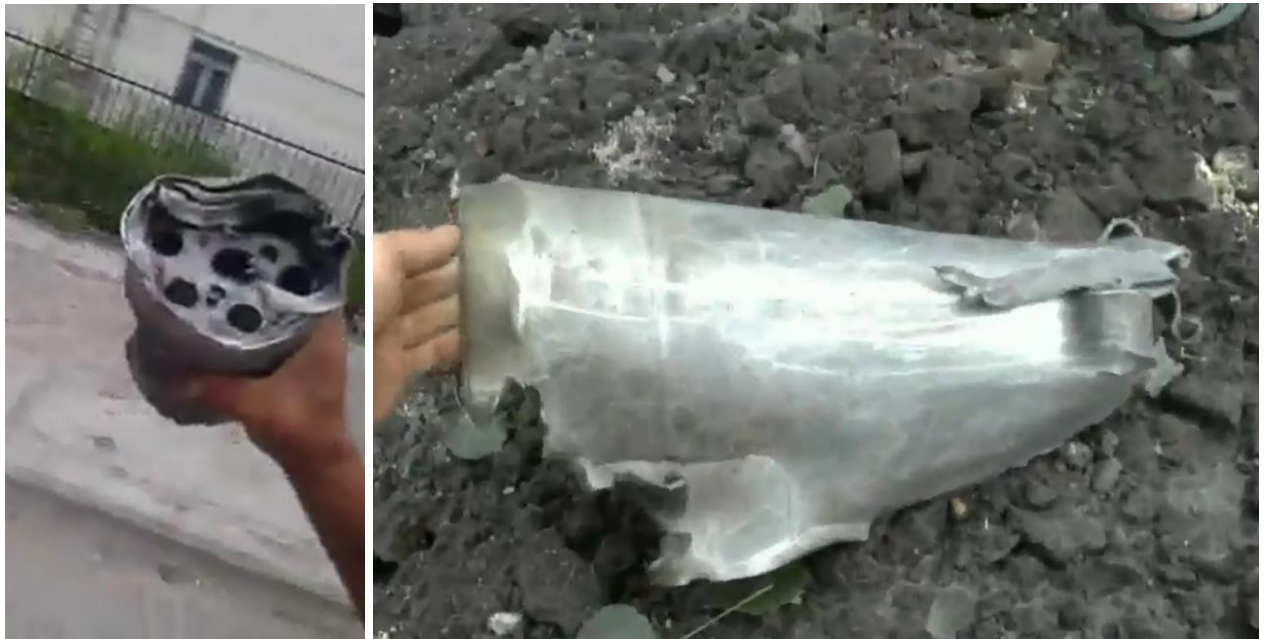
Shell hit 14 (see Fig. 29, see Fig. 30) A shell hit the road pavement about 25 meters from the south-western corner of the building at 3G, Timiryazev St., Luhansk. The projectile detonation resulted in a shell crater.

Fig. 29 - A shell explosion crater located about 25 meters from the south-western corner of the building at 3G, Timiryazev St., Luhansk³⁹.

Fig. 30 – Debris of the projectile missile part found near the crater located 25 meters from the south-western corner of the building at 3G, Timiryazev St., Luhansk ⁴⁰.

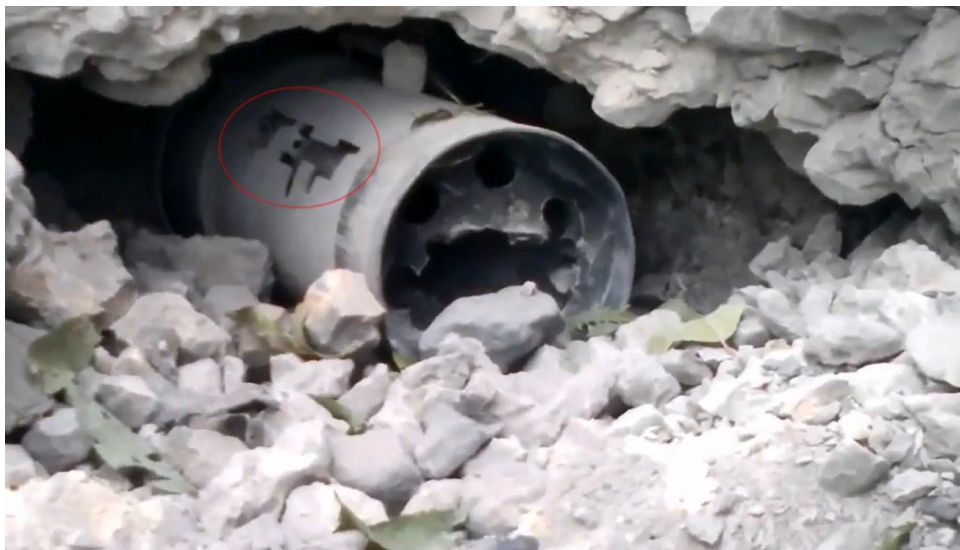
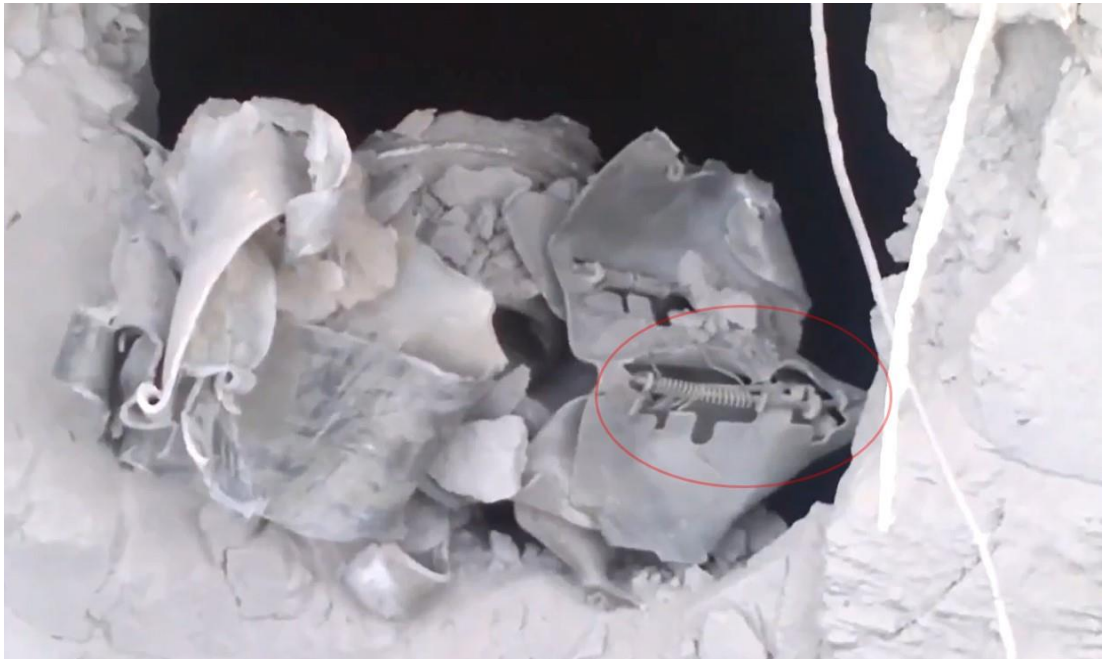
In all the shell hit sites under consideration, the debris of the missile parts of the MLRS projectiles were found. In cases of shell hits 12 and 13 (see Fig. 31 and Fig. 32) the MP debris were found with the shape of holes for tail fin fastening that are typical for the BM-21 Grad MLRS⁶.

Fig. 31 – The shape of the holes for tail fin fastening which is typical for BM-21 “Grad” projectiles at the shell hit 12⁴¹.

Fig. 32 - The shape of the holes for tail fin fastening which is typical for BM-21 “Grad” projectiles at the shell hit 13⁴².
