Shelling of the Mirny and Gayevoy residential quarters in the city of Luhansk with the use of Grad Multiple Launch Rocket Systems on July 14, 2014

PUBLIC INVESTIGATION

Donetsk 29.11.2021

Author: Ivan Aleksandrovich Kopyl

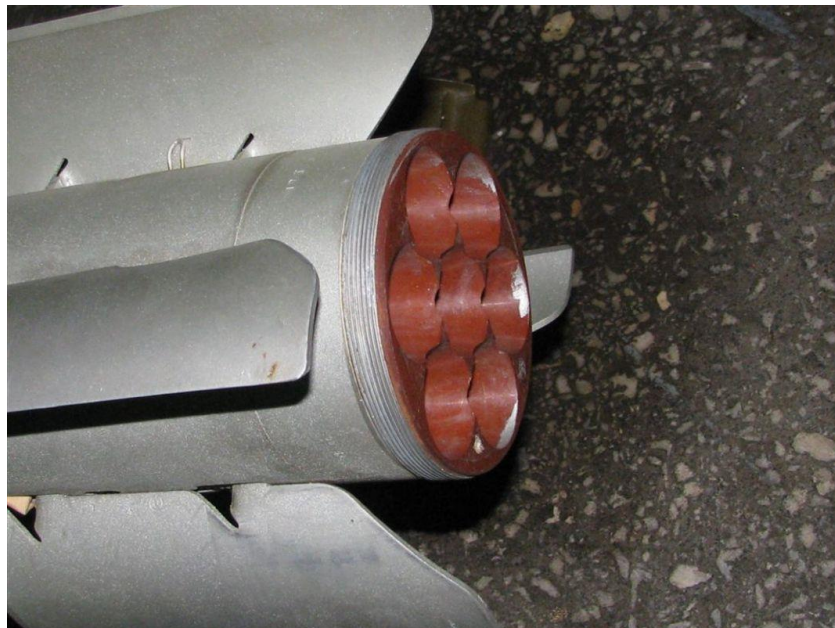
In addition, the Grad MLRS rockets are characterized by the presence of 7 nozzles (see Fig. 33) as opposed to one nozzle on the Smerch MLRS and Uragan MLRS missiles (see Fig. 34 and Fig. 35).

Fig. 33 – View of the stabilizer block and the nozzle block cross-section of the of the 9M22M unguided rocket projectile model⁴³.

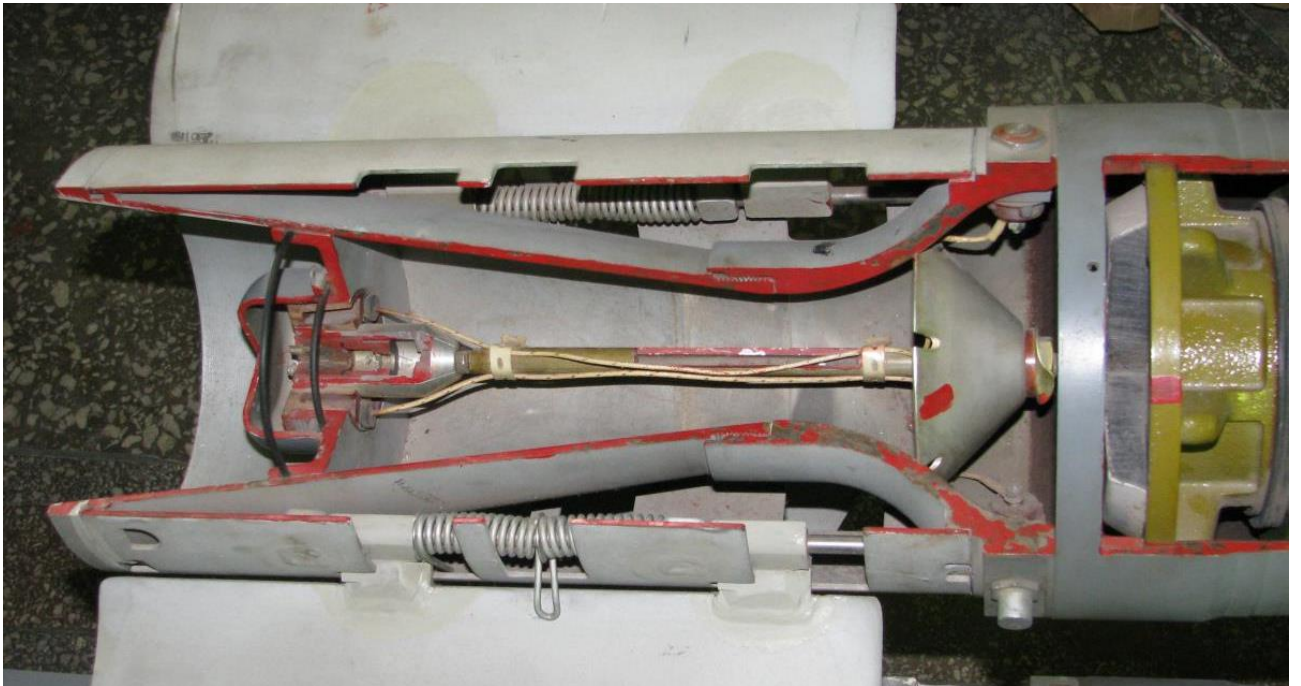
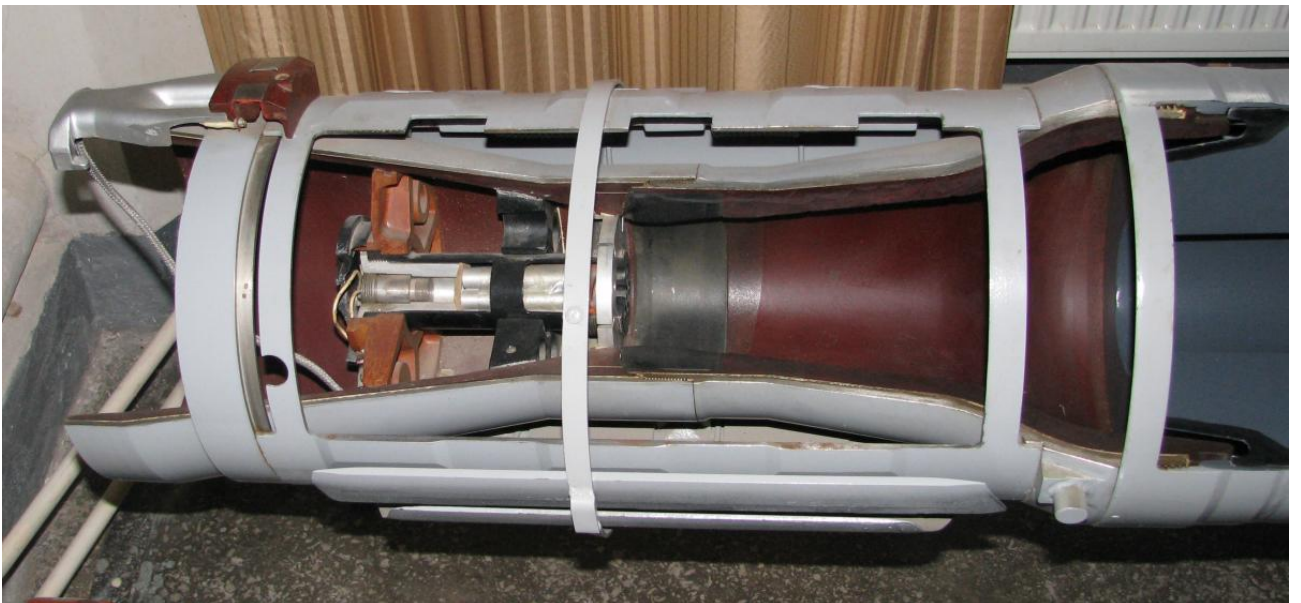
Fig. 34 – Section view of the missile part nozzle of the BM 27 Uragan MLRS rocket projectile⁴⁴.

Fig. 35 – Section view of the missile part nozzle of the "Smerch" (Whirlwind) MLRS rocket projectile⁴⁵.

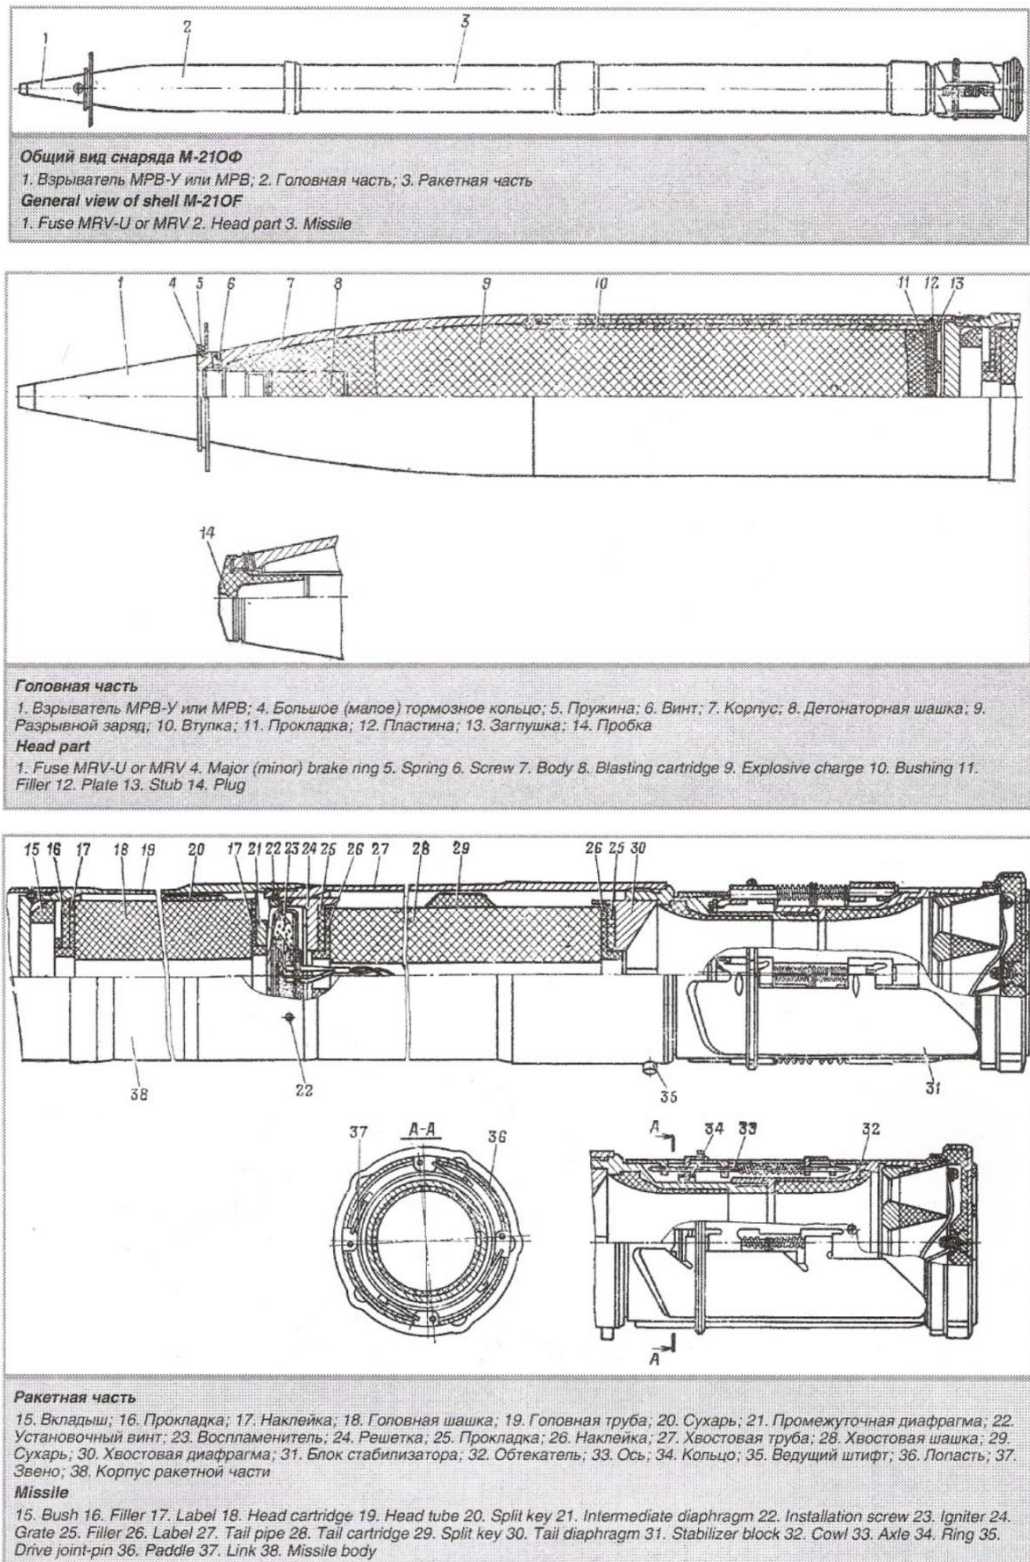
The projectile for firing from 9K51 Grad MLRS consists of a fuze, head and rocket parts. As a result of contact with an obstacle, the detonator initiates an explosion of the shell head, which scatters into fragments. The rocket often remains more or less intact, though deformed. It is usually found either inside the shell crater, or in the immediate vicinity of it. For clarity, we present the design and technical characteristics of the most common projectile used for firing from the 9K51 Grad MLRS (see Fig. 36).

Fig. 36 - M-21OF projectile design (a high explosive fragmentation projectile, used for firing from 9K51 Grad MLRS)⁴⁶.

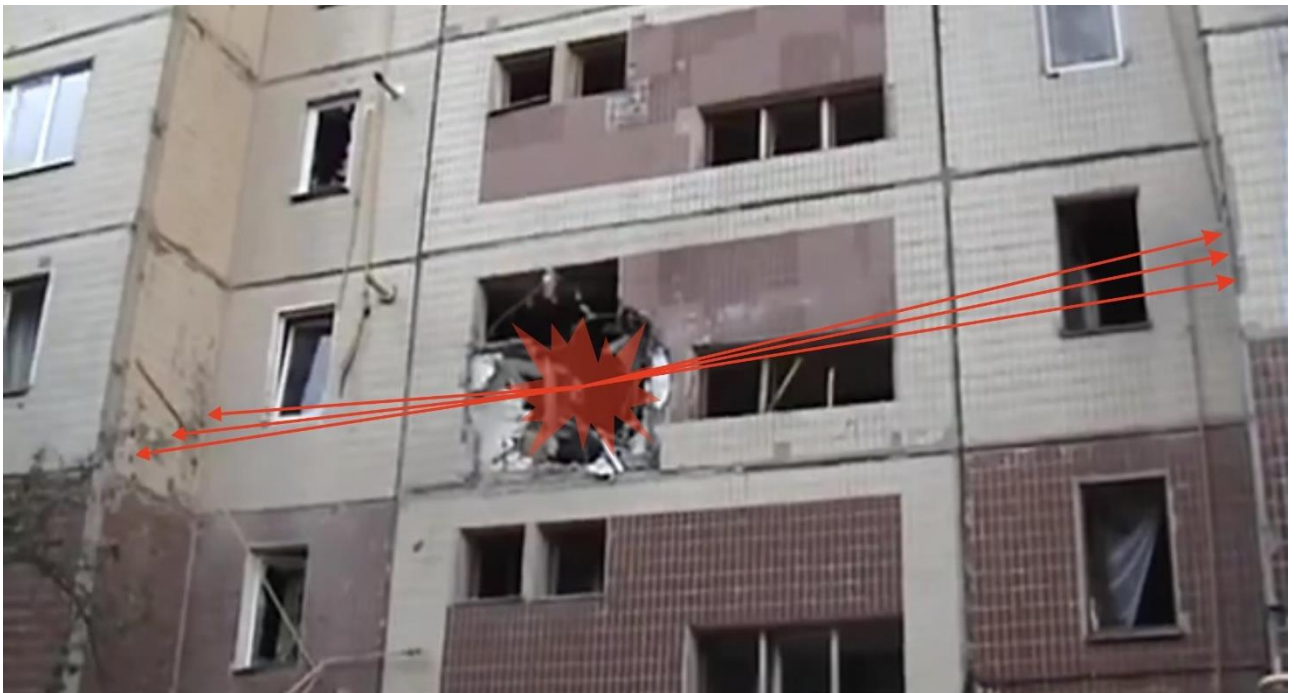
Fig. 38 – The fragment scattering pattern (shell hit 4)⁴⁸.

In case of shell hit 4 the projectile hit the north wall of the building. Moreover, damage from shell fragments left on the wall indicates that the intersection of the building wall plane and the plane of the main scatter of fragments formed an almost horizontal line (see Fig. 38). This suggests that the projectile flew in a direction close to perpendicular to the wall. Considering that building No. 16 in the Olkhovsky residential quarter is oriented strictly to the north, it can be argued that in this case the projectile flew from north to south (see Fig. 39).

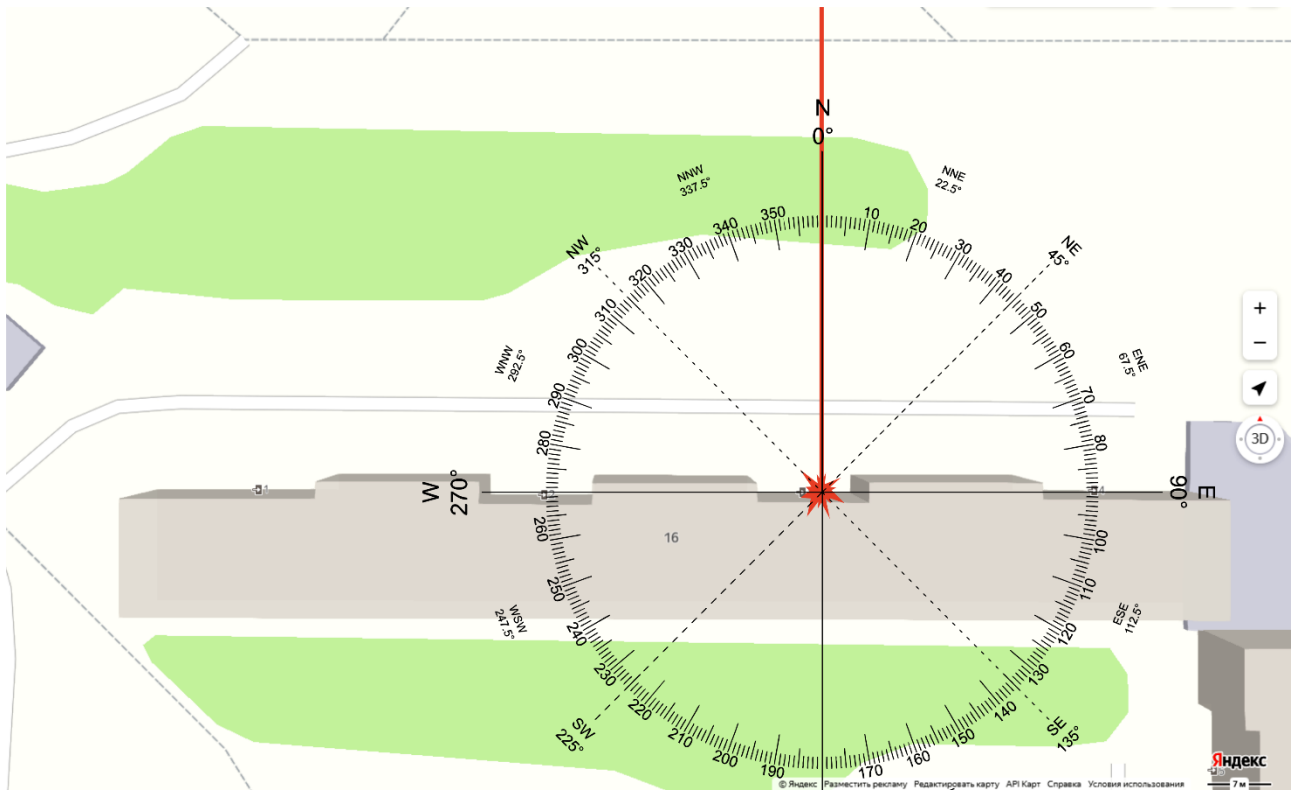
Fig. 39 – Shelling direction in the case of shell hit 4.

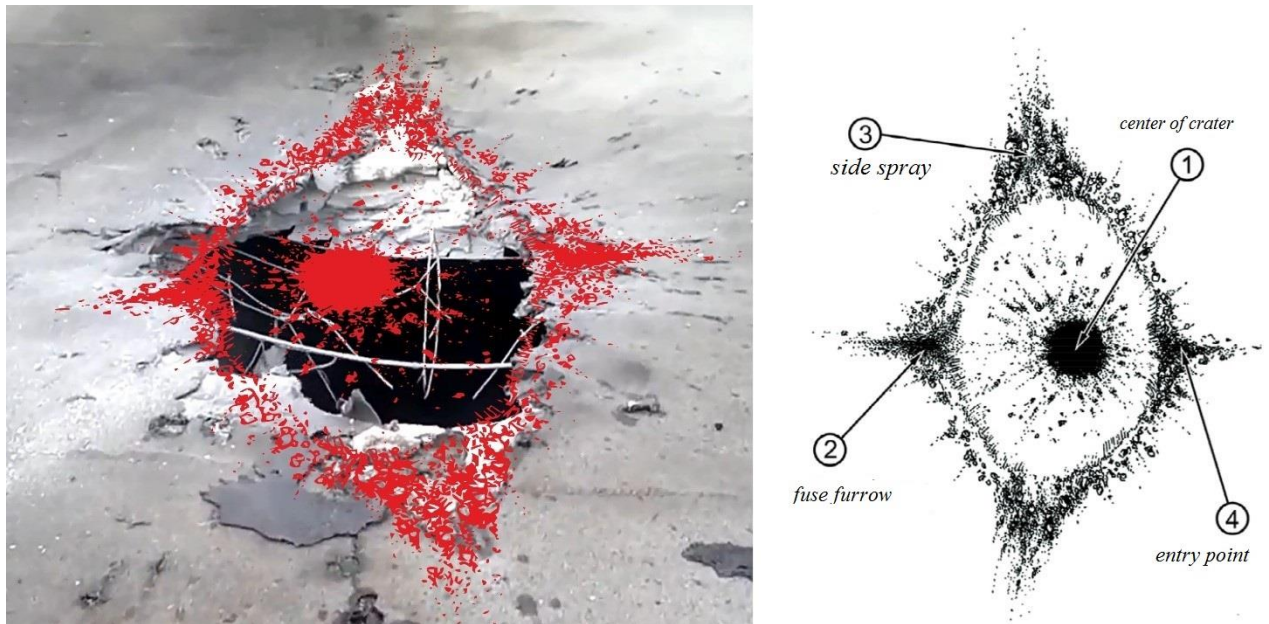
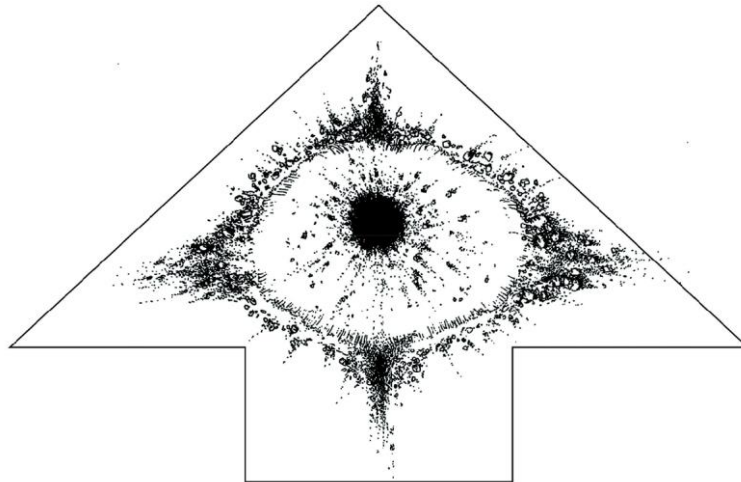
Shell hit 13 has a well-defined shape and corresponds to a shell crater being in contact with the surface at a low striking angle without delayed detonation (see Fig. 40). The shape of such craters forms a kind of an arrow that points to the gun (see Fig. 41).

Fig. 40 – Clear trail shape in case of shell hit 13⁴⁹.

Fig. 41 – Form of the shell crater resulting from contact with the surface at a low striking angle without delayed detonation makes it possible to determine the shelling direction⁵⁰.

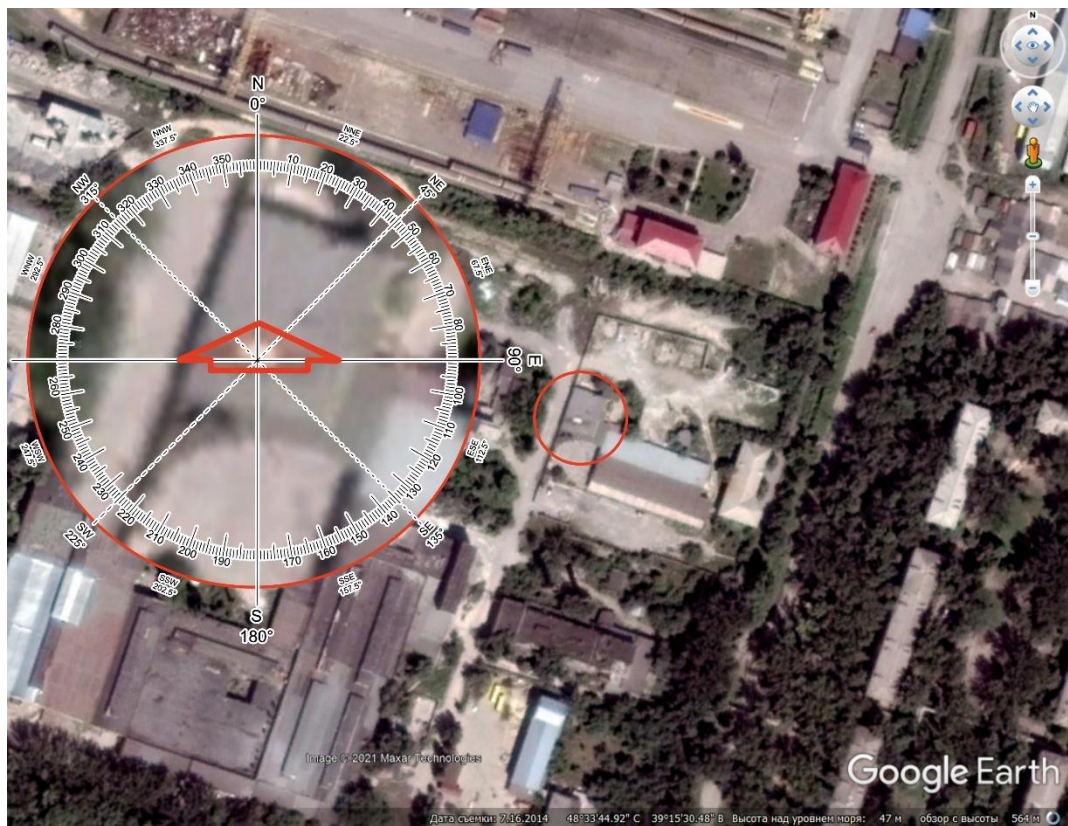
This shell hit is clearly visible in the satellite image and enables to determine the shelling direction (see Fig. 42). As in the previous case, the shelling was carried out in the direction from north to south.

Fig. 42 – Fire direction determination using satellite imagery dated 16.07.2014 (shell hit 13).

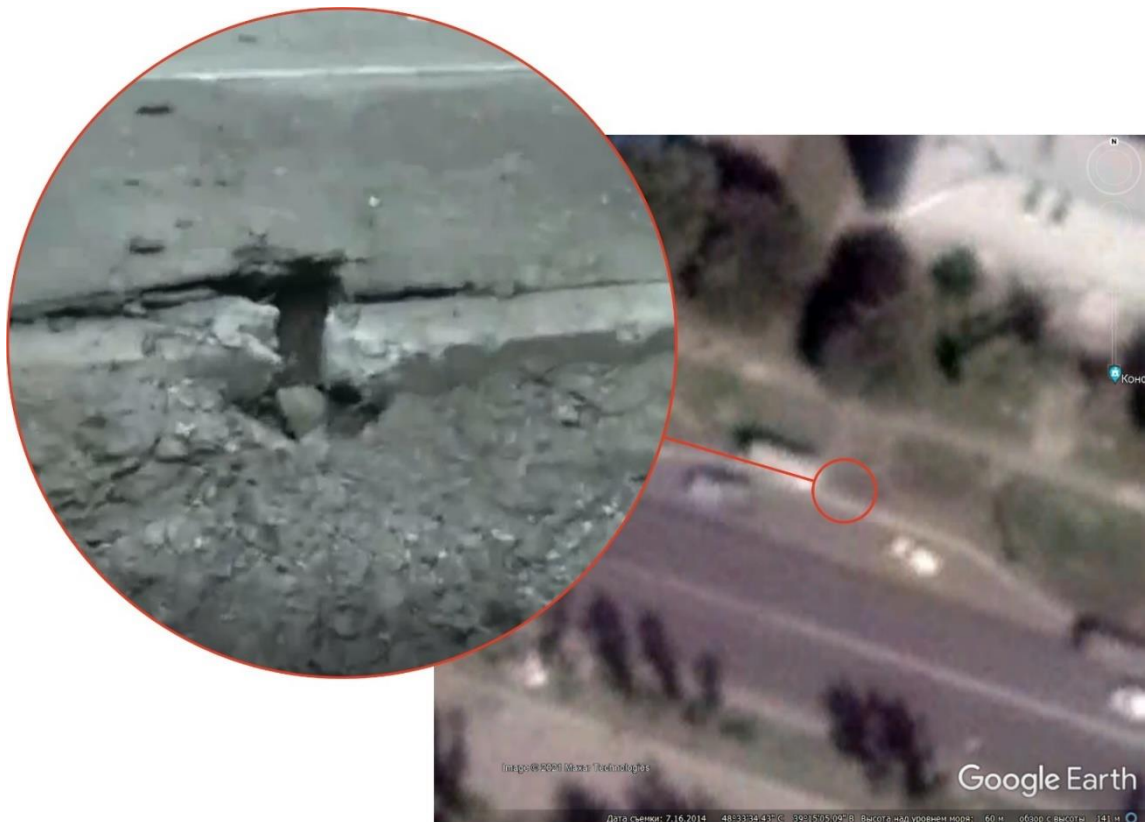
In addition, in the case of shell hit 10, the trail from the main scatter of fragments is observed on the north side of the curb, which was hit by the projectile (see Fig. 43), which indicates the projectile flight direction from north to south.

Fig. 43 – Shell hit 10: trail from the main scatter of fragments on the north side of the curb⁵¹.

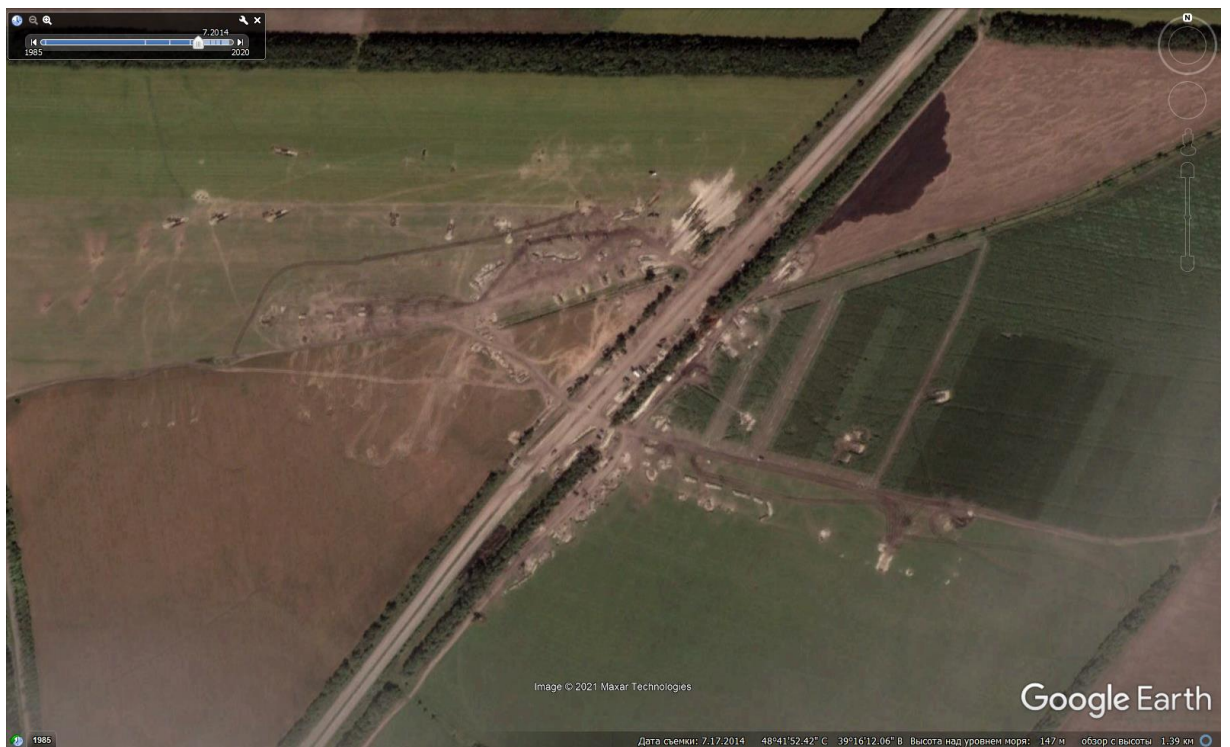
Fig. 46 – Base camp of the 1st Tank Brigade in the vicinity of Veselaya Gora settlement in the satellite image dated 17.07.2014.

The video shows the servicemen of the 1st Tank Brigade (1-st TBr) of the Ukrainian Ground Forces. In the second minute, a soldier named Dmitry says that they have been in positions for more than a month. Thus, it can be stated that on July 14, 2014, a base camp of the 1st TBr was located in the vicinity of Veselaya Gora settlement. Moreover, this base camp is clearly visible in the satellite image dated July 17, 2014 (see Fig. 46).

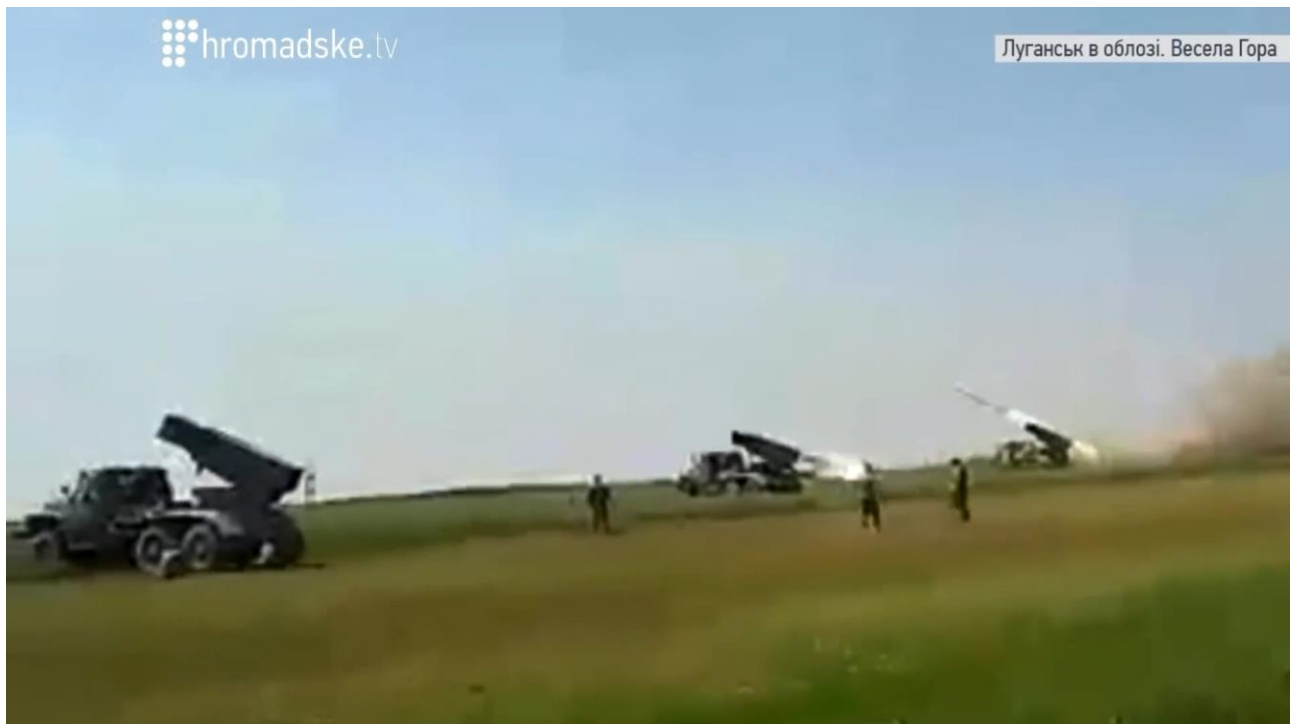
Fig. 47 – Ukrainian BM-21 Grad MLRS are firing in the direction of Luhansk from positions in the vicinity of Veselaya Gora settlement.

According to the Ukrainian version of Wikipedia, the brigade has a rocket artillery battalion¹⁰. This fact is confirmed by the above video, where at the 7th minute three Ukrainian BM-21 Grad MLRSs appear in the frame, that fired towards Luhansk from combat positions (see Fig. 47). From further viewing the video, it becomes clear that these MLRS units are part of the 1st TBr.

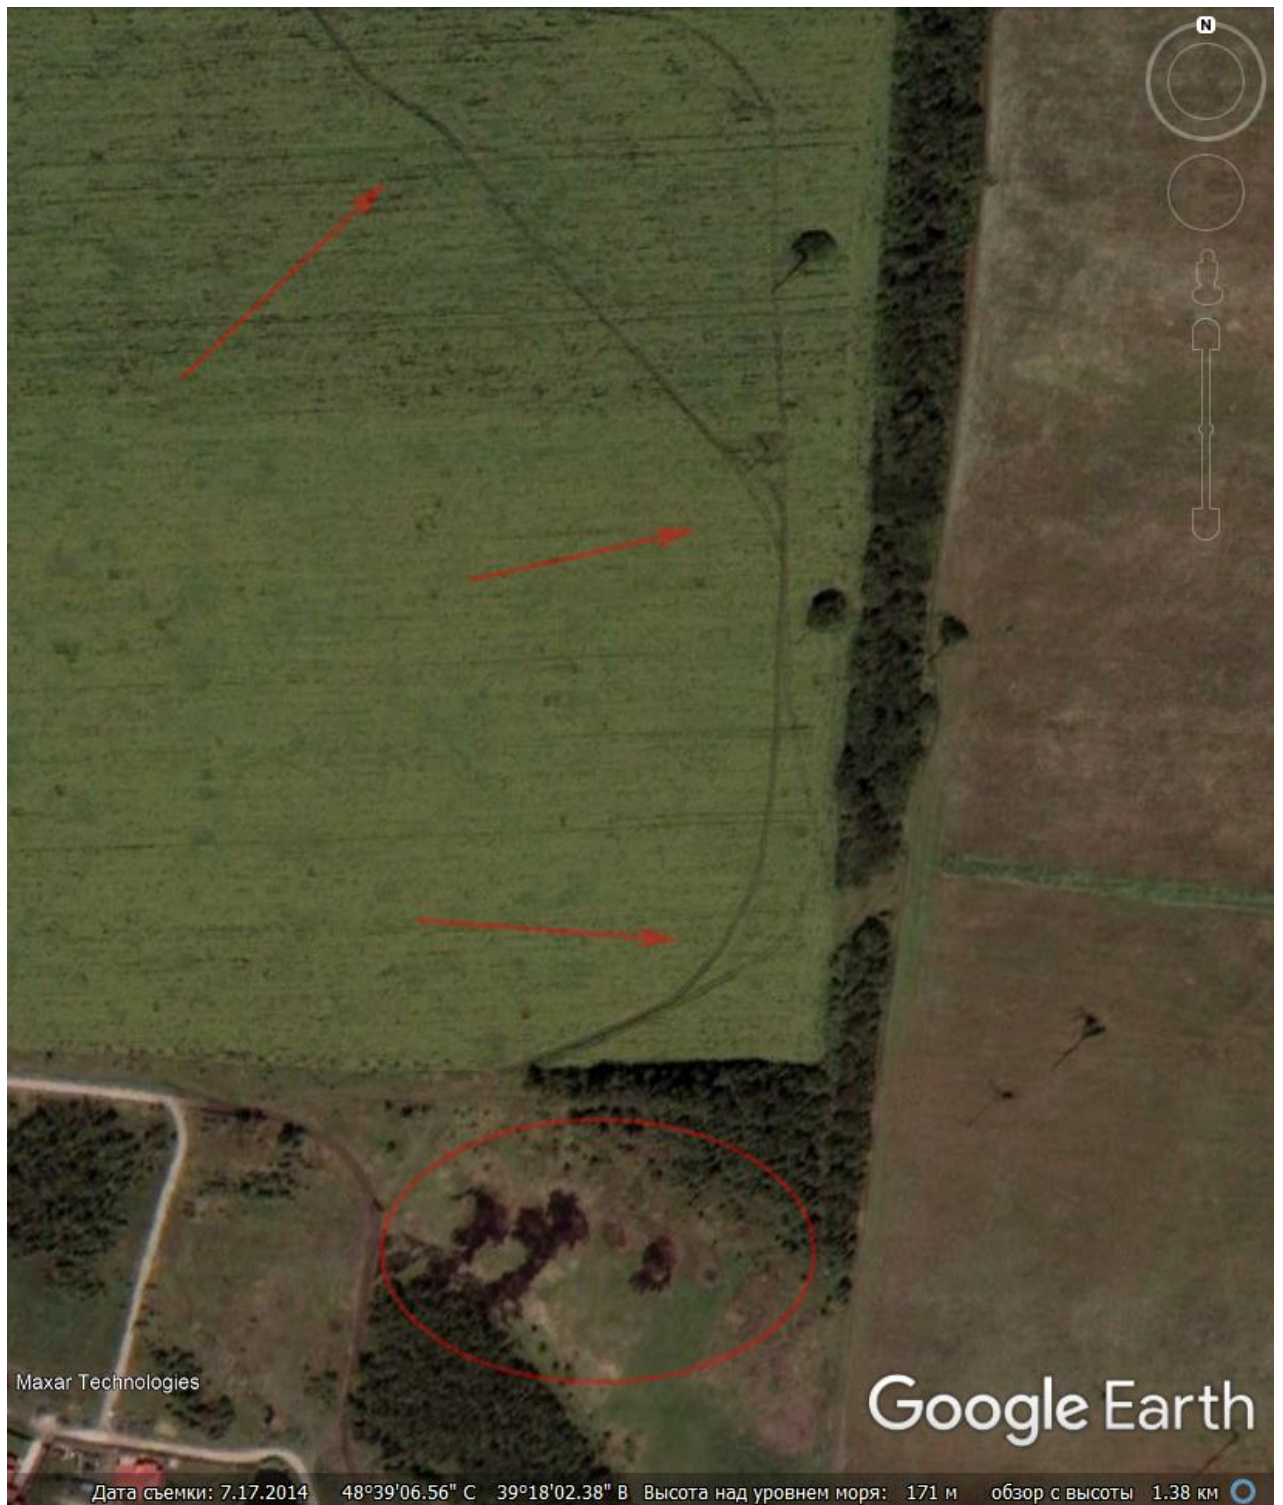
In addition, the satellite image dated July 17, 2014, shows three patches of burnt earth in the vicinity of Stukalova Balka settlement. These patches are very similar to the traces that remain after the launch of missiles from MLRS. Also, in the field to the north of these patches, there are traces of vehicles moving towards them (see Fig. 48).

Fig. 48 – Patches of burnt earth and traces of military equipment movement towards these patches from the north of Stukalova Balka settlement (satellite image dated 17.07.2014).
